Access Compliance Report

Public Rights-of-Way

(Curb Ramps)

Intersection ID: 49893	Main Street: ROCKY_FORD_CLUB_RD	Cross Street: RIDGEVIEW_COMMONS_DR	Location: W
ADA ID: 1A3B331787BA	Ramp Type: Perp	Initial Pass/Fail: Fail	Overall Compliance: No
		Severity Score: 22.5

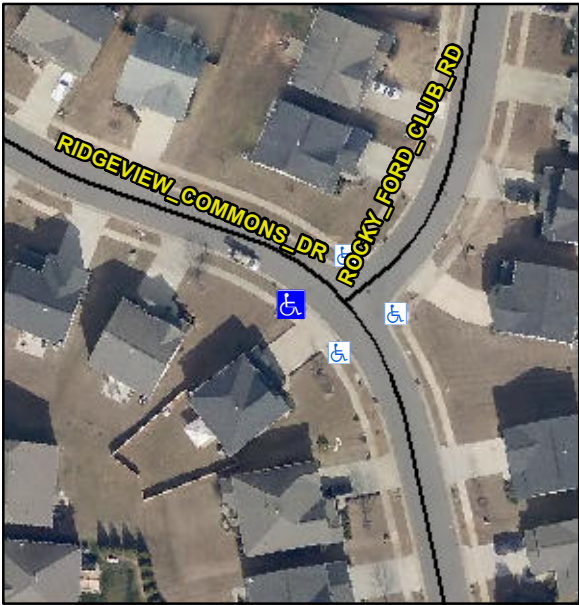
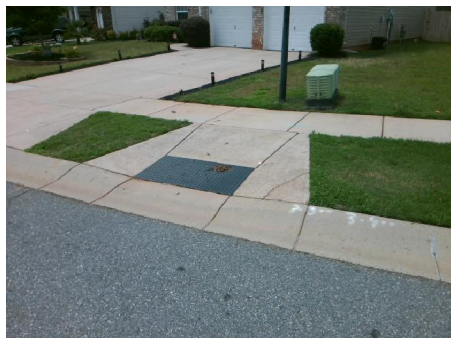
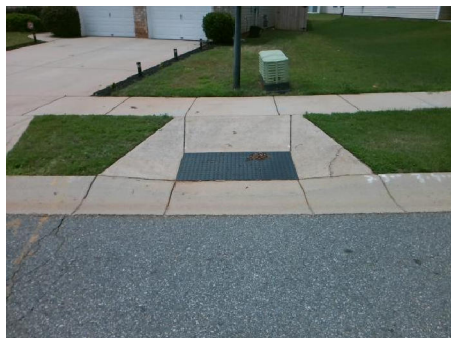
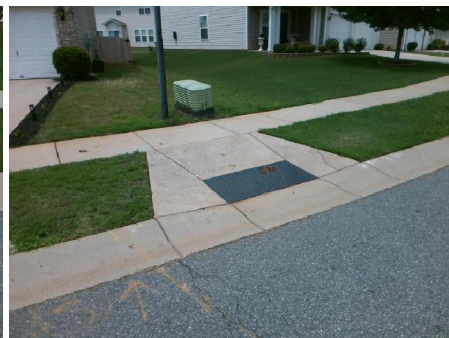
<p>Street 1 Name RIDGEVIEW COMMONS DR</p> <p>Stop Condition-Street 2 None</p> <p>Street 2 Name N/A</p> <p>Stop Condition-Street 1 N/A</p>	Possible Solutions:		Compliance	Description	Data	Compliance	Description	Data
	Remove & Replace Entire Ramp.		N/A	Ramp Length (in)	70.0	No	Ramp Slope (%)	9.3
			No	Ramp Width (in)	47.0	No	Ramp XSlope (%)	3.2
			N/A	Flare Type LT	N/A	N/A	Flare Type RT	N/A
			N/A	Flare Slope LT (%)	N/A	N/A	Flare Slope RT (%)	N/A
			N/A	Flare Traversable LT?	N/A	N/A	Flare Traversable RT?	N/A
			N/A	Landing Length (in)	N/A	N/A	DWS Provided?	N/A
			N/A	Landing Width (in)	N/A	N/A	DWS Contrast?	N/A
			N/A	Landing Slope (%)	N/A	N/A	DWS Length (in)	N/A
			N/A	Landing X Slope (%)	N/A	N/A	DWS Full Width?	N/A
Surveyor Notes:		N/A	N/A	Landing Curb? (Y/N)	N/A	N/A	DWS Offset (in)	N/A
			N/A	Shared Landing?	N/A

PROW/ADA:			N/A	Gutter Ponding?	N/A	N/A	Gutter Slope (%)	N/A
R304.5.1, R304.2.2, R304.5.3			N/A	Gutter Lip Ht (in)	N/A	N/A	Gutter X Slope (%)	N/A
			N/A	Painted X Walk1?	No	N/A	Painted X Walk2?	N/A
				X Walk 1 Direction	To NE		X Walk 2 Direction	N/A
			N/A	X Walk 1 Width (in)	N/A	N/A	X Walk 2 Width (in)	N/A
				X Walk 1 Slope (%)	1.6		X Walk 2 Slope (%)	N/A
				X Walk 1 X Slope (%)	2.0		X Walk 2 X Slope (%)	N/A
			N/A	Ramp inside XWalk1?	N/A	N/A	Ramp inside XWalk2?	N/A
				Road Slope (%)	N/A	N/A	Clear Space?	N/A
				Road X Slope (%)	N/A	N/A	Clear Space to XWalk (in)	N/A
			N/A	Any Obstructions?	N/A	N/A	Storm Grate/Utility Hazard?	N/A
				Obstruction Type			Storm Grate/Utility Type	
					N/A			N/A
						Yes	Surface Condition? (G/P)	Good
Total Cost:		\$ 1850.00
