# Access Compliance Report

## Public Rights-of-Way

### (Curb Ramps)

| Intersection ID: 49135 | Main Street: AMBER_LEIGH_WAY_DR | Cross Street: AMESBURY_HILL_DR | Location: W |

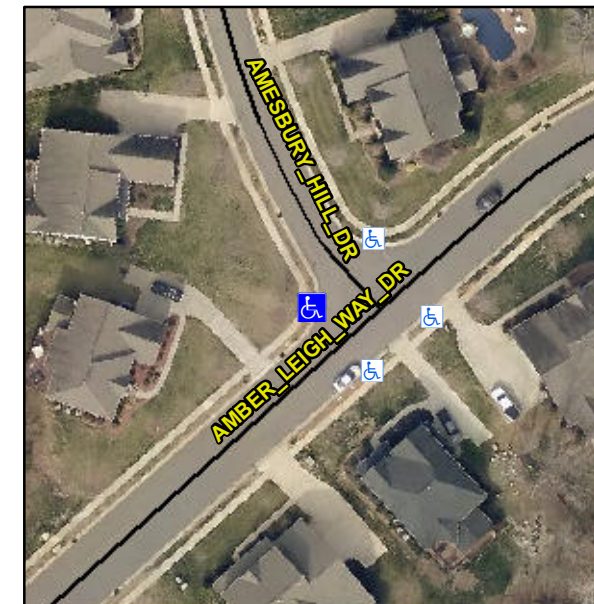
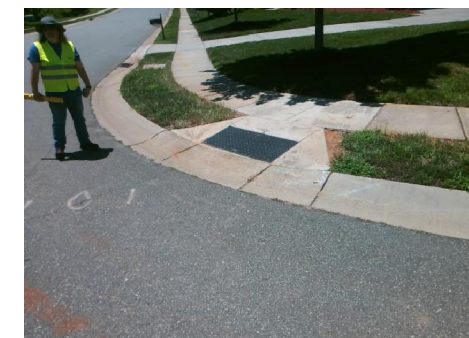
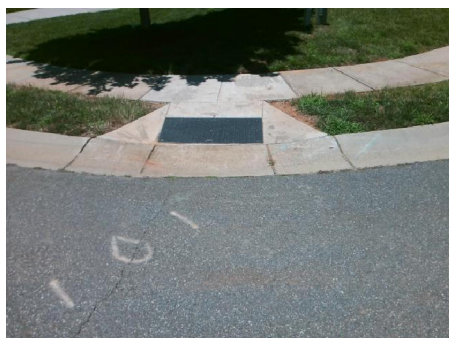
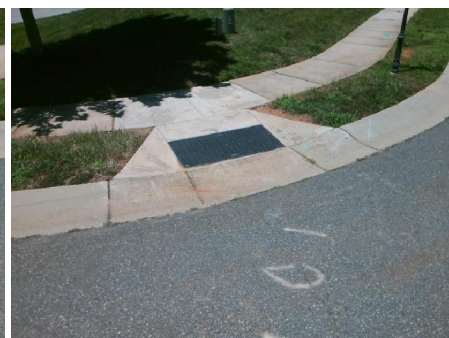
| ADA ID: 1A4AF3B18C31 | Ramp Type: PerpDiag | Initial Pass/Fail: Fail | Overall Compliance: No |

| Compliance | Description | Data | Compliance | Description | Data |
|---|---|---|---|---|---|
| N/A | Ramp Length (in) | 44.0 | No | Ramp Slope (%) | 11.1 |
| No | Ramp Width (in) | 47.5 | No | Ramp XSlope (%) | 3.1 |

**Remove & Replace Curb Ramp With Two New Directional Ramps or Equivalent.**
