Access Compliance Report

Public Rights-of-Way

(Curb Ramps)

Intersection ID: 12671	Main Street: SEIGLE_AV	Cross Street: GREENWAY_CRESCENT_LN	Location: NW
ADA ID: 1A4BD1679C99	Ramp Type: Directional1	Initial Pass/Fail: Fail	Overall Compliance: No
Severity Score: 1.25			
Codes/Mitigation Info/Possible Solution		Field Measurements/Component Compliance

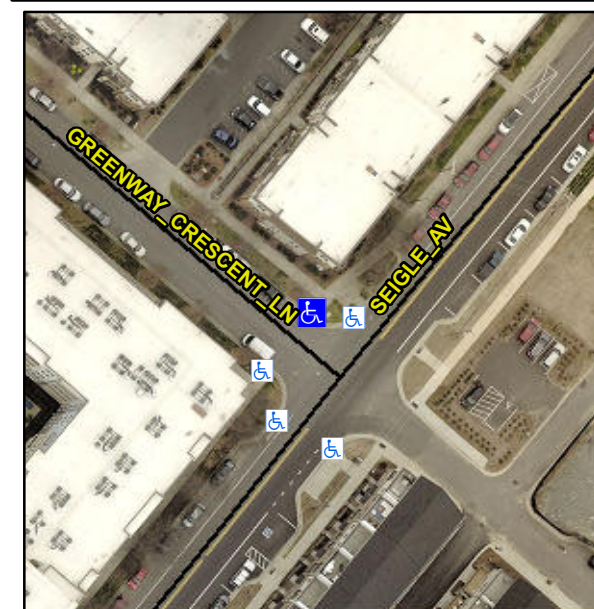
Compliance	Description	Data	Compliance	Description	Data
N/A	Ramp Length (in)	95.5	N/A	Grade Break?	N/A
Yes	Ramp Width (in)	70.0	N/A	Grade Break Slope (%)	0.0
Yes	Ramp Slope (%)	6.8	N/A	Grade Break XSlope (%)	0.0
No	Ramp XSlope (%)	4.6			
N/A	Flare Type LT	N/A	N/A	Flare Type RT	N/A
N/A	Flare Slope LT (%)	N/A	N/A	Flare Slope RT (%)	0.0
N/A	Flare Traversable LT?	N/A	N/A	Flare Traversable RT?	N/A
N/A	Landing Length (in)	0.0	N/A	DWS Provided?	N/A
N/A	Landing Width (in)	0.0	N/A	DWS Contrast?	N/A
N/A	Landing Slope (%)	0.0	N/A	DWS Length (in)	N/A
N/A	Landing X Slope (%)	0.0	N/A	DWS Full Width?	N/A
N/A	Landing Curb? (Y/N)	N/A	N/A	DWS Offset LT (in)	N/A
N/A	Shared Landing?	N/A	N/A	DWS Offset RT (in)	N/A
N/A	Gutter Ponding?	0.0	N/A	Gutter Slope (%)	N/A
N/A	Gutter Lip Ht (in)	0.0	N/A	Gutter X Slope (%)	N/A
N/A	Painted X Walk1?	No		Road Slope (%)	0.5
	X Walk 1 Direction	To SW		Road X Slope (%)	5.1
	X Walk 1 Width (in)	N/A		Clear Space?	N/A

X Walk 1 Slope (%)	0.5	N/A	Clear Space to XWalk (in)	N/A
	X Walk 1 X Slope (%)	5.1	N/A	Storm Grate/Utility Hazard?	N/A
N/A	Ramp inside XWalk1?	N/A		Storm Grate/Utility Type	
N/A	Any Obstructions?	N/A			N/A
	Obstruction Type		Yes	Surface Condition? (G/P)	Good
			N/A	Curb Slope (%)	10.1

Possible Solutions:

Remove & Replace Entire Ramp.
