# Access Compliance Report

## Public Rights-of-Way

| Intersection ID: 20526 | Main Street: ARROWCREEK_DR | Cross Street: S_TRYON_ST | Location: NE |
| ADA ID: 1A53C684EE7C | Ramp Type: PerpDiag | Initial Pass/Fail: Fail | Overall Compliance: No |

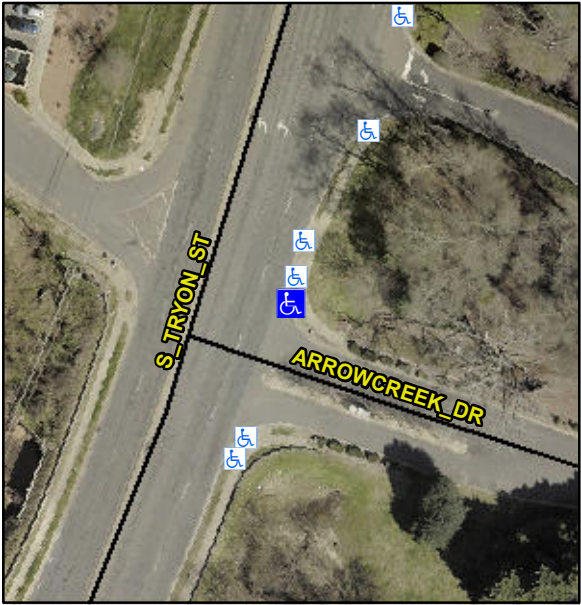
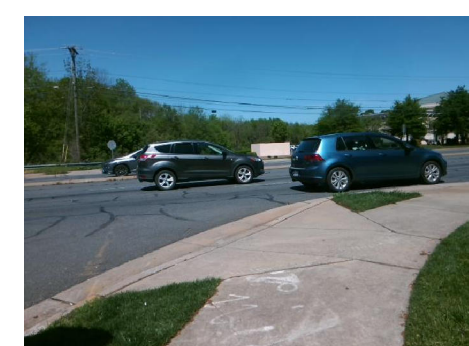
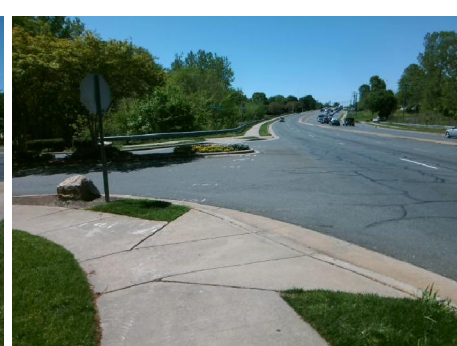
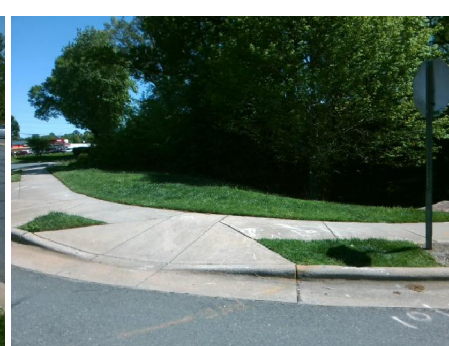
| | | Severity Score: 22.5 | |

| Codes/Mitigation Info/Possible Solution | | | Field Measurements/Component Compliance | | |
|--|---|---|---|---|---|
| | <b>Remove &amp; Replace Curb Ramp With Two New Directional Ramps or Equivalent.</b> | | <b>No</b> | Ramp Length (in) | <b>65.0</b> |
| | | | <b>No</b> | Ramp Width (in) | <b>42.0</b> |
| <p>PROW/ADA:</p> <p><b>Not Found, R304.5.1, R304.2.2, R304.5.3</b></p> | | | <b>No</b> | Painted X Walk2? | <b>No</b> |

| Codes/Mitigation Info/Possible Solution | | | Field Measurements/Component Compliance | | |
|--|---|---|---|---|---|
| Total Cost: | | <b>\$ 3200.00</b> | | | |
