# Access Compliance Report

## Public Rights-of-Way

### (Curb Ramps)

| Intersection ID: 10350 | Main Street: BANCROFT_ST | Cross Street: KESWICK_AV | Location: NE |

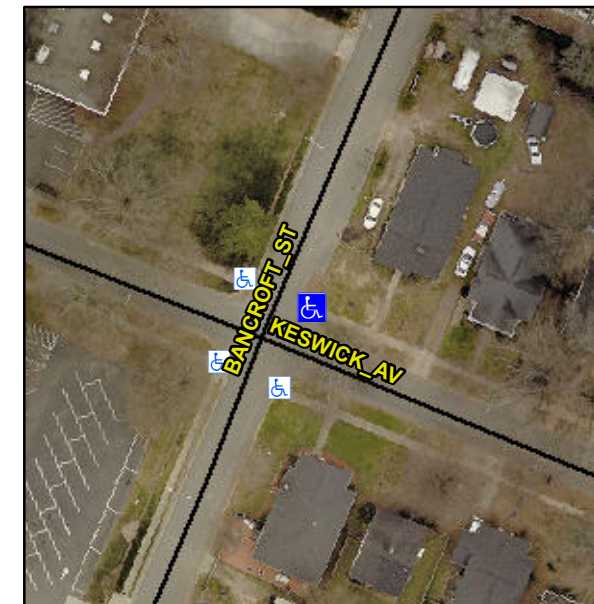
**Not Found, R304.2.1, R304.2.2-Perp, R304.3.2-Para, R304.5.3, R302.7**

| Compliance | Description | Data | Compliance | Description | Data |
|---|---|---|---|---|---|
| No | Landing Length (in) | 46.0 | Yes | DWS Provided? | Yes |
| No | Landing Slope (%) | 3.4 | Yes | DWS Length (in) | 24.5 |
| No | Landing X Slope (%) | 2.6 | Yes | DWS Full Width? | Yes |
| No | Gutter Ponding? | Yes | Yes | Gutter Slope (%) | 2.6 |
| Yes | Gutter Lip Ht (in) | 0.0 | No | Gutter X Slope (%) | 3.1 |

**Remove & Replace Curb Ramp With Two New Directional Ramps or Equivalent. Remove & Replace Gutter.**

Total Cost: \$ 3950.00
