Access Compliance Report Public Rights-of-Way (Curb Ramps)

Intersection ID: 12701 Main Street: HICKORY GROVE RD **Cross Street: MARKET ST** Location: SE **ADA ID: 1A824ACBE096** Ramp Type: Perp Initial Pass/Fail: Fail **Overall Compliance: No** Severity Score: 21.25

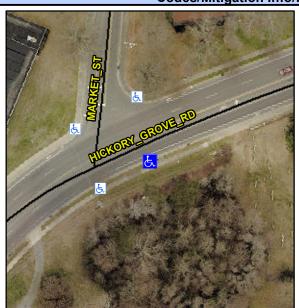
| N/A | Ramp Length (in) | 48.0 | No | Ramp Slope (%) | 8.8 |
| No | Ramp Width (in) | 47.0 | Yes | Ramp XSlope (%) | 1.7 |

Possible Solutions: Remove & Replace Entire Ramp. Surveyor Notes: N/A PROW/ADA: R304.5.1, R304.2.2

1850.00
