# Access Compliance Report

## Public Rights-of-Way

### (Curb Ramps)

Intersection ID: 11389	Main Street: E_18TH_ST	Cross Street: N_CALDWELL_ST	Location: E
ADA ID: 1A832FEFE1C2	Ramp Type: PerpDiag	Initial Pass/Fail: Fail	Overall Compliance: No
		Severity Score: 37.5

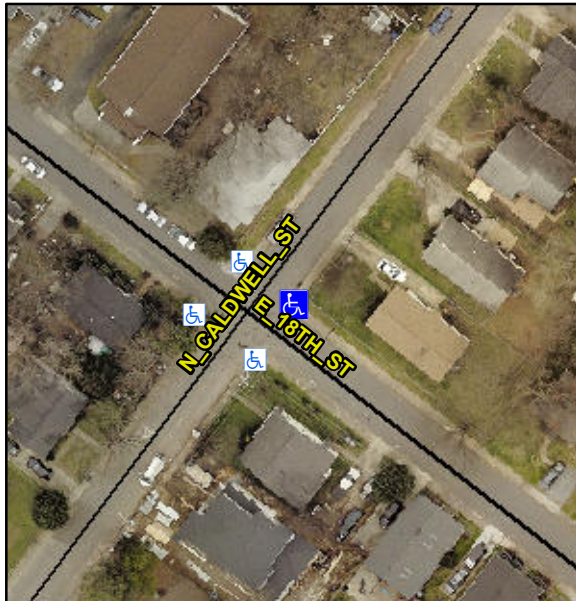
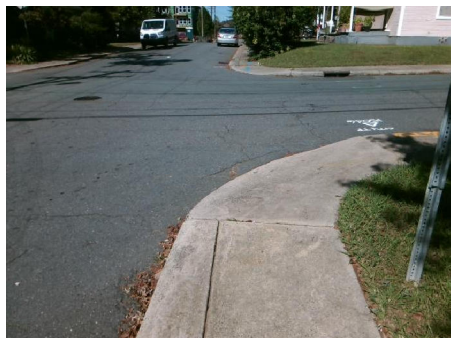
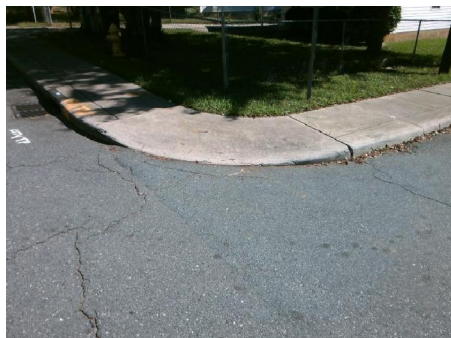
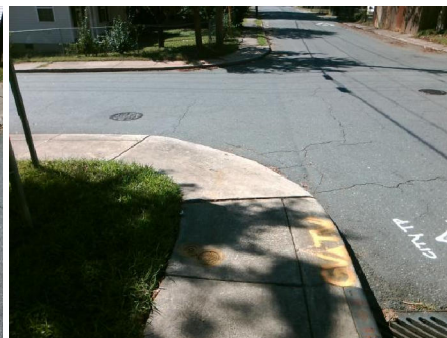
**Not Found, R304.2.2, R304.5.3**

Compliance	Description	Data	Compliance	Description	Data
N/A	Ramp Length (in)	54.0	No	Ramp Slope (%)	15.4
Yes	Ramp Width (in)	51.0	No	Ramp XSlope (%)	6.6
N/A	Flare Type LT	N/A	N/A	Flare Type RT	N/A
N/A	Flare Slope LT (%)	N/A	N/A	Flare Slope RT (%)	N/A
N/A	Flare Traversable LT?	N/A	N/A	Flare Traversable RT?	N/A
N/A	Landing Length (in)	N/A	N/A	DWS Provided?	N/A
N/A	Landing Width (in)	N/A	N/A	DWS Contrast?	N/A
N/A	Landing Slope (%)	N/A	N/A	DWS Length (in)	N/A
N/A	Landing X Slope (%)	N/A	N/A	DWS Full Width?	N/A
N/A	Landing Curb? (Y/N)	N/A	N/A	DWS Offset (in)	N/A
N/A	Shared Landing?	N/A			
N/A	Gutter Ponding?	N/A	N/A	Gutter Slope (%)	N/A
N/A	Gutter Lip Ht (in)	N/A	N/A	Gutter X Slope (%)	N/A
N/A	Painted X Walk1?	No	N/A	Painted X Walk2?	No
	X Walk 1 Direction	To SW		X Walk 2 Direction	To NW
N/A	X Walk 1 Width (in)	N/A	N/A	X Walk 2 Width (in)	N/A
	X Walk 1 Slope (%)	4.3		X Walk 2 Slope (%)	2.1
	X Walk 1 X Slope (%)	1.5		X Walk 2 X Slope (%)	3.9

N/A	Ramp inside XWalk1?	N/A	N/A	Ramp inside XWalk2?	N/A
	Road Slope (%)	5.6	N/A	Clear Space?	N/A
	Road X Slope (%)	0.6	N/A	Clear Space to XWalk (in)	N/A
N/A	Any Obstructions?	N/A	N/A	Storm Grate/Utility Hazard?	N/A
	Obstruction Type			Storm Grate/Utility Type	
		N/A			N/A
			Yes	Surface Condition? (G/P)	Good

**Remove & Replace Curb Ramp With Two New Directional Ramps or Equivalent.**
