Access Compliance Report

Public Rights-of-Way

(Curb Ramps)

Intersection ID: 42727	Main Street: SPEEDWELL_CT	Cross Street: PICKEREL_LN	Location: W
ADA ID: 1A8B0EC71B06	Ramp Type: PerpDiag	Initial Pass/Fail: Fail	Overall Compliance: No
Severity Score: 8.75			
Codes/Mitigation Info/Possible Solution		Field Measurements/Component Compliance

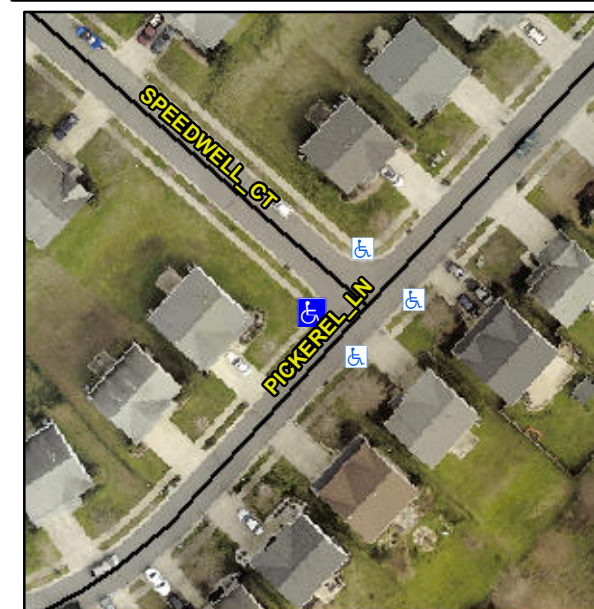
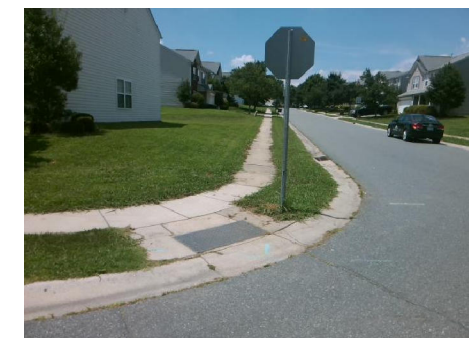
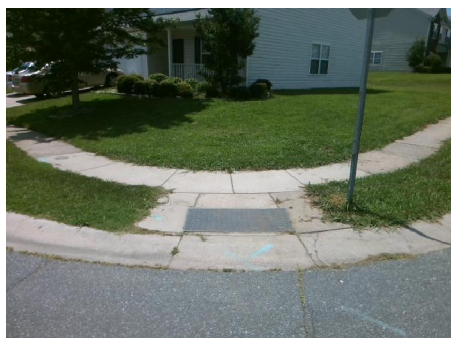
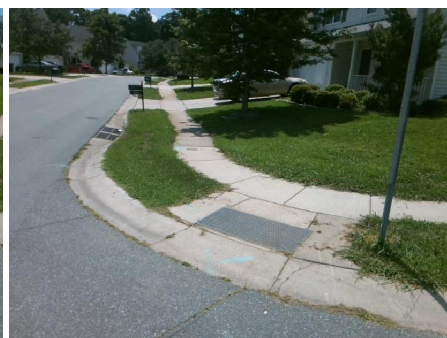
Not Found, R304.5.1

Compliance	Description	Data	Compliance	Description	Data
N/A	Ramp Length (in)	49.0	Yes	Ramp Slope (%)	5.0
No	Ramp Width (in)	38.0	Yes	Ramp XSlope (%)	1.7
N/A	Flare Type LT	N/A	N/A	Flare Type RT	N/A
N/A	Flare Slope LT (%)	N/A	N/A	Flare Slope RT (%)	N/A
N/A	Flare Traversable LT?	N/A	N/A	Flare Traversable RT?	N/A
N/A	Landing Length (in)	N/A	N/A	DWS Provided?	N/A
N/A	Landing Width (in)	N/A	N/A	DWS Contrast?	N/A
N/A	Landing Slope (%)	N/A	N/A	DWS Length (in)	N/A
N/A	Landing X Slope (%)	N/A	N/A	DWS Full Width?	N/A
N/A	Landing Curb? (Y/N)	N/A	N/A	DWS Offset (in)	N/A
N/A	Shared Landing?	N/A			
N/A	Gutter Ponding?	N/A	N/A	Gutter Slope (%)	N/A
N/A	Gutter Lip Ht (in)	N/A	N/A	Gutter X Slope (%)	N/A
N/A	Painted X Walk1?	No	N/A	Painted X Walk2?	No
	X Walk 1 Direction	To SE		X Walk 2 Direction	To NE
N/A	X Walk 1 Width (in)	N/A	N/A	X Walk 2 Width (in)	N/A
	X Walk 1 Slope (%)	1.5		X Walk 2 Slope (%)	5.0
	X Walk 1 X Slope (%)	2.8		X Walk 2 X Slope (%)	1.3

N/A	Ramp inside XWalk1?	N/A	N/A	Ramp inside XWalk2?	N/A
	Road Slope (%)	1.7	N/A	Clear Space?	N/A
	Road X Slope (%)	4.2	N/A	Clear Space to XWalk (in)	N/A
N/A	Any Obstructions?	N/A	N/A	Storm Grate/Utility Hazard?	N/A
	Obstruction Type			Storm Grate/Utility Type	
		N/A			N/A
			Yes	Surface Condition? (G/P)	Good

Remove & Replace Curb Ramp With Two New Directional Ramps or Equivalent.
