Access Compliance Report

Public Rights-of-Way

(Curb Ramps)

| Intersection ID: 31864 | Main Street: ARABELLA_DR | Cross Street: LANGDEN_GATE_DR | Location: SE |

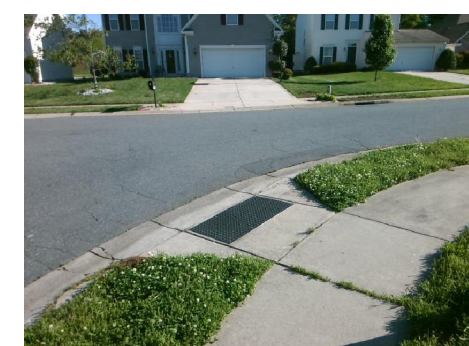
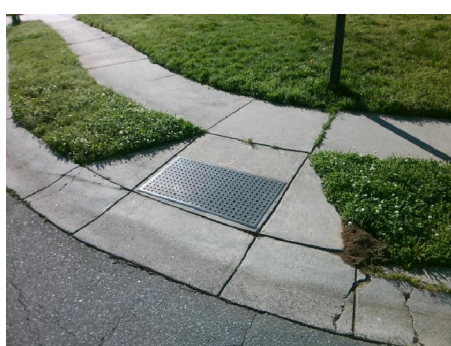
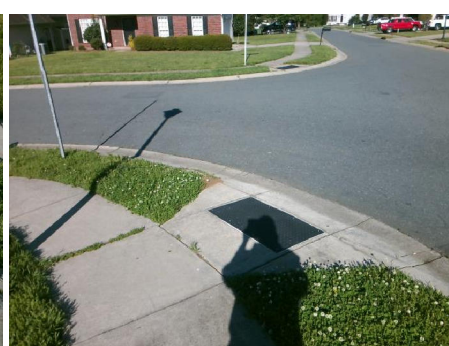
| ADA ID: 1AA30704F738 | Ramp Type: PerpDiag | Initial Pass/Fail: Fail | Overall Compliance: No |

| Severity Score: 12.5 | | | |

PROW/ADA:

Not Found, R304.5.3

| Compliance | Description | Data | Compliance | Description | Data |
|---|---|---|---|---|---|
| N/A | Ramp Length (in) | 48.0 | Yes | Ramp Slope (%) | 5.3 |
| Yes | Ramp Width (in) | 48.0 | No | Ramp XSlope (%) | 5.4 |

Possible Solutions:

Remove & Replace Curb Ramp With Two New Directional Ramps or Equivalent.

Total Cost: \$ 3200.00
