Access Compliance Report

Public Rights-of-Way

(Curb Ramps)

Intersection ID: 21011	Main Street: CORONATION_BV	Cross Street: SARDIS_RD_NORTH	Location: E
ADA ID: 1AADB20ED2BE	Ramp Type: Perp	Initial Pass/Fail: Fail	Overall Compliance: No
Severity Score: 37.5			
Codes/Mitigation Info/Possible Solution		Field Measurements/Component Compliance

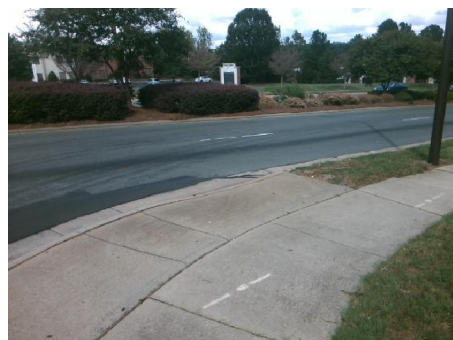
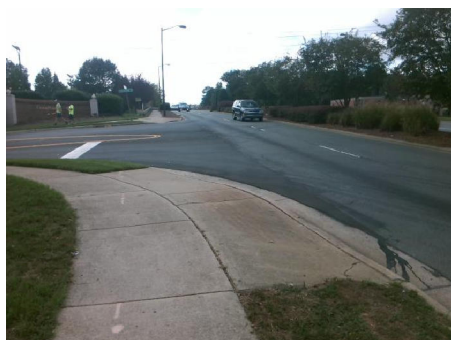
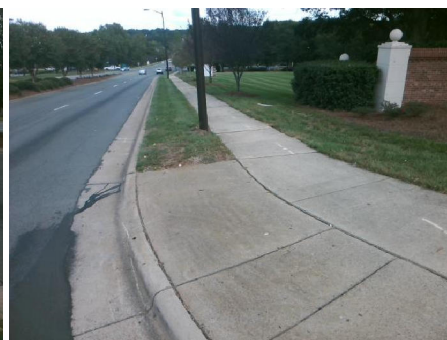
Not Found, R304.2.2, R304.5.3

Compliance	Description	Data	Compliance	Description	Data
N/A	Ramp Length (in)	64.0	No	Ramp Slope (%)	13.5
Yes	Ramp Width (in)	48.0	No	Ramp XSlope (%)	5.9
N/A	Flare Type LT	N/A	N/A	Flare Type RT	N/A
N/A	Flare Slope LT (%)	N/A	N/A	Flare Slope RT (%)	N/A
N/A	Flare Traversable LT?	N/A	N/A	Flare Traversable RT?	N/A
N/A	Landing Length (in)	N/A	N/A	DWS Provided?	N/A
N/A	Landing Width (in)	N/A	N/A	DWS Contrast?	N/A
N/A	Landing Slope (%)	N/A	N/A	DWS Length (in)	N/A
N/A	Landing X Slope (%)	N/A	N/A	DWS Full Width?	N/A
N/A	Landing Curb? (Y/N)	N/A	N/A	DWS Offset (in)	N/A
N/A	Shared Landing?	N/A			
N/A	Gutter Ponding?	N/A	N/A	Gutter Slope (%)	N/A
N/A	Gutter Lip Ht (in)	N/A	N/A	Gutter X Slope (%)	N/A
N/A	Painted X Walk1?	No	N/A	Painted X Walk2?	N/A
	X Walk 1 Direction	To NW		X Walk 2 Direction	N/A
N/A	X Walk 1 Width (in)	N/A	N/A	X Walk 2 Width (in)	N/A
	X Walk 1 Slope (%)	3.2		X Walk 2 Slope (%)	N/A
	X Walk 1 X Slope (%)	7.2		X Walk 2 X Slope (%)	N/A

N/A	Ramp inside XWalk1?	N/A	N/A	Ramp inside XWalk2?	N/A
	Road Slope (%)	N/A	N/A	Clear Space?	N/A
	Road X Slope (%)	N/A	N/A	Clear Space to XWalk (in)	N/A
N/A	Any Obstructions?	N/A	N/A	Storm Grate/Utility Hazard?	N/A
	Obstruction Type			Storm Grate/Utility Type	
		N/A			N/A
		Yes		Surface Condition? (G/P)	Good

Remove & Replace Entire Ramp.
