Access Compliance Report

Public Rights-of-Way

(Curb Ramps)

Intersection ID: 17405	Main Street: RIDGEWOOD_AV	Cross Street: WESTFIELD_RD	Location: NW
ADA ID: 1AC2CE356566	Ramp Type: Perp	Initial Pass/Fail: Fail	Overall Compliance: No
		Severity Score: 12.5

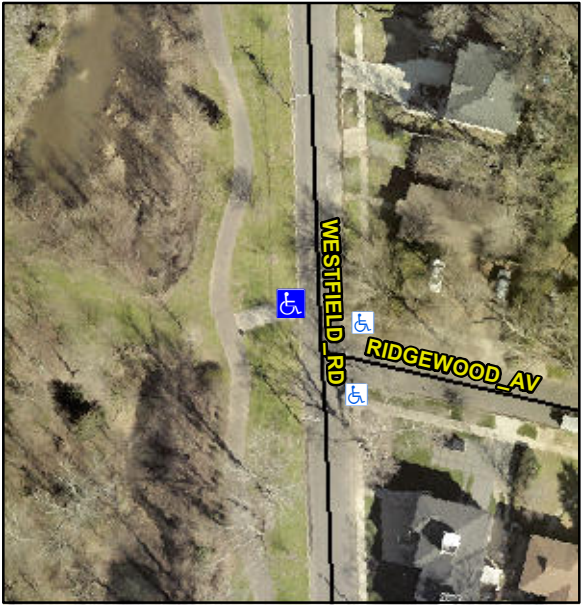
Possible Solutions:		Compliance	Description	Data
	Remove & Replace Entire Ramp.		No	Ramp Length (in)	80.0
			Yes	Ramp Width (in)	120.0
			N/A	Flare Type LT	N/A
			N/A	Flare Slope LT (%)	N/A
			N/A	Flare Traversable LT?	N/A
			N/A	Landing Length (in)	N/A
			N/A	Landing Width (in)	N/A
			N/A	Landing Slope (%)	N/A
			N/A	Landing X Slope (%)	N/A
<p>Surveyor Notes:</p> <p>N/A</p> <p>PROW/ADA:</p> <p>Not Found, R304.2.2</p>			N/A	Flare Type RT	N/A
			N/A	Flare Slope RT (%)	N/A
			N/A	Flare Traversable RT?	N/A
			N/A	DWS Provided?	N/A
			N/A	DWS Contrast?	N/A
			N/A	DWS Length (in)	N/A
			N/A	DWS Full Width?	N/A
			N/A	DWS Offset (in)	N/A
			N/A	Gutter Ponding?	N/A
			N/A	Gutter Lip Ht (in)	N/A
			No	Painted X Walk1?	N/A
				X Walk 1 Direction	To SE
			N/A	X Walk 1 Width (in)	N/A
				X Walk 1 Slope (%)	6.1
				X Walk 1 X Slope (%)	3.5

N/A	Ramp inside XWalk1?	N/A
			N/A	Road Slope (%)	N/A
			N/A	Road X Slope (%)	N/A
			N/A	Any Obstructions?	N/A
				Obstruction Type	
Total Cost:					
		\$ 1850.00			
			N/A	Clear Space?	N/A
			N/A	Clear Space to XWalk (in)	N/A
			N/A	Storm Grate/Utility Hazard?	N/A
				Storm Grate/Utility Type	
			N/A		N/A
			Yes	Surface Condition? (G/P)	Good
