# Access Compliance Report

## Public Rights-of-Way

### (Curb Ramps)

Intersection ID: 31885	Main Street: SLALOM_HILL_RD	Cross Street: SPRUCE_PEAK_RD	Location: NW
ADA ID: 1ACC1A233FC1	Ramp Type: PerpDiag	Initial Pass/Fail: Fail	Overall Compliance: No
Severity Score: 31.25			
Codes/Mitigation Info/Possible Solution		Field Measurements/Component Compliance

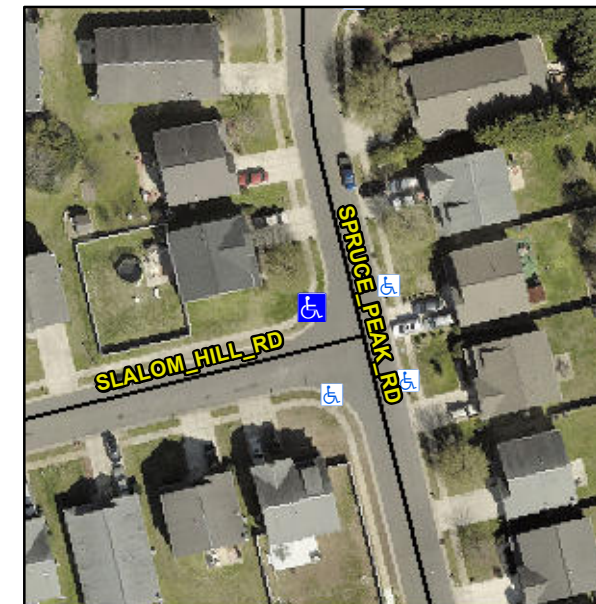
Compliance	Description	Data	Compliance	Description	Data
N/A	Ramp Length (in)	47.0	No	Ramp Slope (%)	10.3
No	Ramp Width (in)	34.0	No	Ramp XSlope (%)	3.9
N/A	Flare Type LT	N/A	N/A	Flare Type RT	N/A
N/A	Flare Slope LT (%)	N/A	N/A	Flare Slope RT (%)	N/A
N/A	Flare Traversable LT?	N/A	N/A	Flare Traversable RT?	N/A
N/A	Landing Length (in)	N/A	N/A	DWS Provided?	N/A
N/A	Landing Width (in)	N/A	N/A	DWS Contrast?	N/A
N/A	Landing Slope (%)	N/A	N/A	DWS Length (in)	N/A
N/A	Landing X Slope (%)	N/A	N/A	DWS Full Width?	N/A
N/A	Landing Curb? (Y/N)	N/A	N/A	DWS Offset (in)	N/A
N/A	Shared Landing?	N/A			
N/A	Gutter Ponding?	N/A	N/A	Gutter Slope (%)	N/A
N/A	Gutter Lip Ht (in)	N/A	N/A	Gutter X Slope (%)	N/A
N/A	Painted X Walk1?	No	N/A	Painted X Walk2?	No
	X Walk 1 Direction	To S		X Walk 2 Direction	To E
N/A	X Walk 1 Width (in)	N/A	N/A	X Walk 2 Width (in)	N/A
	X Walk 1 Slope (%)	1.3		X Walk 2 Slope (%)	5.9
	X Walk 1 X Slope (%)	3.8		X Walk 2 X Slope (%)	0.3

N/A	Ramp inside XWalk1?	N/A	N/A	Ramp inside XWalk2?	N/A
	Road Slope (%)	4.2	N/A	Clear Space?	N/A
	Road X Slope (%)	1.3	N/A	Clear Space to XWalk (in)	N/A
N/A	Any Obstructions?	N/A	N/A	Storm Grate/Utility Hazard?	N/A
	Obstruction Type			Storm Grate/Utility Type	
		N/A			N/A
		Yes		Surface Condition? (G/P)	Good

**Remove & Replace Curb Ramp With Two New Directional Ramps or Equivalent.**
