Access Compliance Report

Public Rights-of-Way

(Curb Ramps)

| Intersection ID: 13959 | Main Street: CLEVELAND_AV | Cross Street: E_PARK_AV | Location: W |

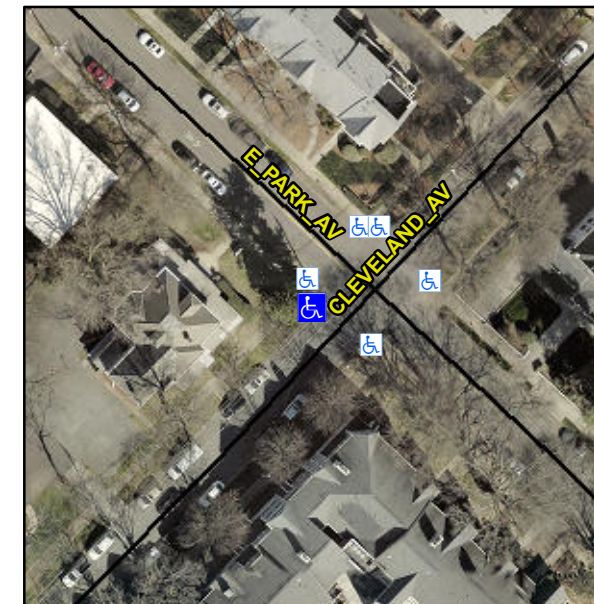
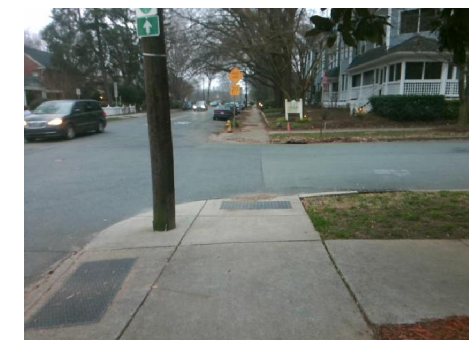
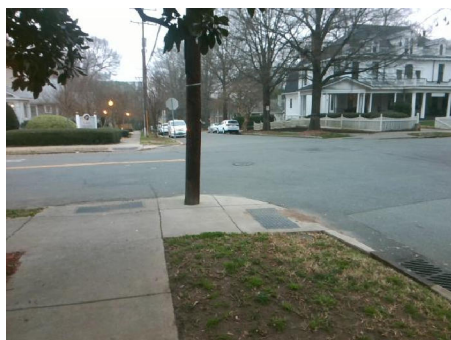
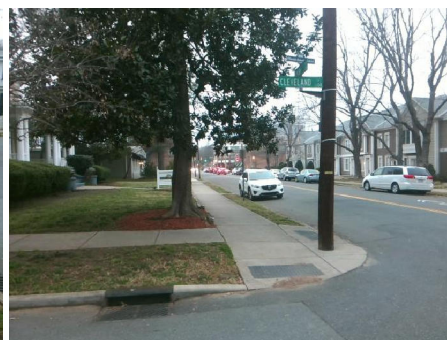
| ADA ID: 1ACC92968DE3 | Ramp Type: Directional1 | Initial Pass/Fail: Fail | Overall Compliance: No |

| | | Severity Score: 1.25 | |

R304.5.3

| Compliance | Description | Data | Compliance | Description | Data |
|---|---|---|---|---|---|
| No | Ramp XSlope (%) | 2.9 | | | |

Remove & Replace Entire Ramp.

\$ 1600.00
