# Access Compliance Report

## Public Rights-of-Way

### (Curb Ramps)

Intersection ID: 5967	Main Street: N_TRYON_ST	Cross Street: MCCULLOUGH_DR	Location:	E
ADA ID: 1ACF975675EE	Ramp Type: BlendTrans1	Initial Pass/Fail: Fail	Overall Compliance: No	Severity Score: 8.75

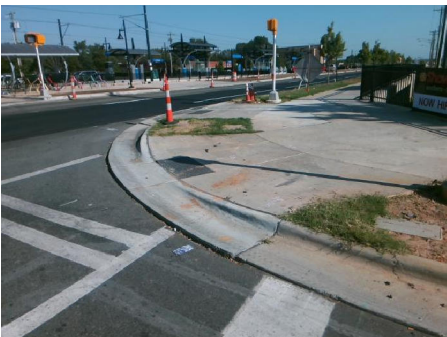
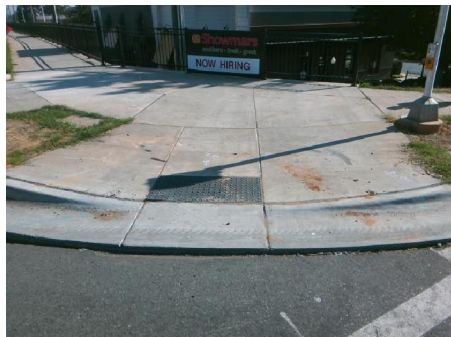
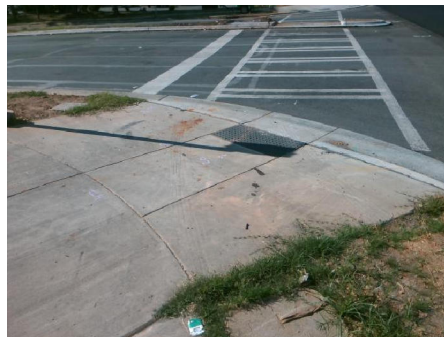
**DAMAGED DWS**

**Not Found, R304.5.1**

Compliance	Description	Data	Compliance	Description	Data
N/A	Ramp Length (in)	94.0	Yes	BlendTrans Slope (%)	3.6
No	Ramp Width (in)	47.0	Yes	BlendTrans XSlope (%)	2.0
N/A	Flare Type LT	N/A	N/A	Flare Type RT	N/A
N/A	Flare Slope LT (%)	N/A	N/A	Flare Slope RT (%)	N/A
N/A	Flare Traversable LT?	N/A	N/A	Flare Traversable RT?	N/A
N/A	Landing Length (in)	N/A	N/A	DWS Provided?	N/A
N/A	Landing Width (in)	N/A	N/A	DWS Contrast?	N/A
N/A	Landing Slope (%)	N/A	N/A	DWS Length (in)	N/A
N/A	Landing X Slope (%)	N/A	N/A	DWS Full Width?	N/A
N/A	Landing Curb? (Y/N)	N/A	N/A	DWS Offset (in)	N/A
N/A	Shared Landing?	N/A			
N/A	Gutter Ponding?	N/A	N/A	Gutter Slope (%)	N/A
N/A	Gutter Lip Ht (in)	2.0	N/A	Gutter X Slope (%)	N/A
N/A	Painted X Walk1?	Yes	N/A	Painted X Walk2?	N/A
	X Walk 1 Direction	To SW		X Walk 2 Direction	N/A
	X Walk 1 Width (in)	119.0		X Walk 2 Width (in)	N/A
	X Walk 1 Slope (%)	0.9		X Walk 2 Slope (%)	N/A
	X Walk 1 X Slope (%)	3.9		X Walk 2 X Slope (%)	N/A

N/A	Ramp inside XWalk1?	Yes	N/A	Ramp inside XWalk2?	N/A
	Road Slope (%)	3.9		Clear Space?	N/A
	Road X Slope (%)	0.9	N/A	Clear Space to XWalk (in)	N/A
N/A	Any Obstructions?	N/A	N/A	Storm Grate/Utility Hazard?	N/A
	Obstruction Type			Storm Grate/Utility Type	
		N/A			N/A
			Yes	Surface Condition? (G/P)	Good
			No	Curb Slope (%)	7.6

**Remove & Replace Curb Ramp With Two New Directional Ramps or Equivalent.**
