# Access Compliance Report

## Public Rights-of-Way

### (Curb Ramps)

Intersection ID: 10023269	Main Street: CHELTON RIDGE LN	Cross Street: N/A	Location: NW
ADA ID: 1AD2E15F3DCE	Ramp Type: PerpDiag	Initial Pass/Fail: Fail	Overall Compliance: No
Severity Score: 33.75			
Codes/Mitigation Info/Possible Solution		Field Measurements/Component Compliance

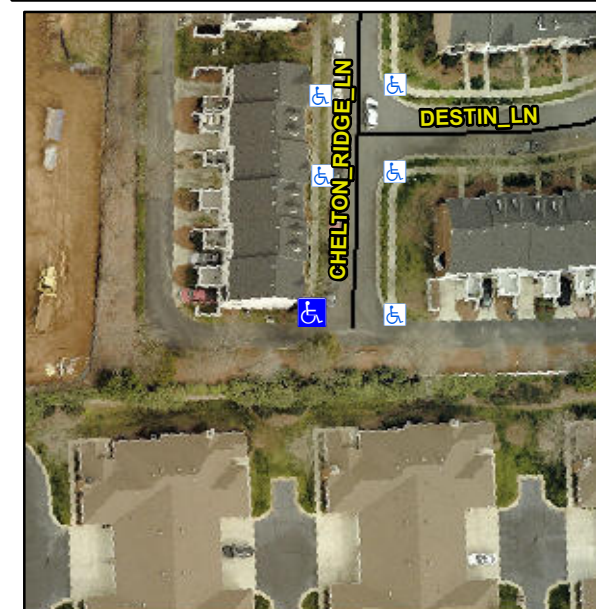
PROW/ADA:

**Not Found, R304.5.1, R304.5.3**

Compliance	Description	Data	Compliance	Description	Data
N/A	Ramp Length (in)	96.0	Yes	Ramp Slope (%)	5.3
No	Ramp Width (in)	46.0	No	Ramp XSlope (%)	10.5
N/A	Flare Type LT	N/A	N/A	Flare Type RT	N/A
N/A	Flare Slope LT (%)	N/A	N/A	Flare Slope RT (%)	N/A
N/A	Flare Traversable LT?	N/A	N/A	Flare Traversable RT?	N/A
N/A	Landing Length (in)	N/A	N/A	DWS Provided?	N/A
N/A	Landing Width (in)	N/A	N/A	DWS Contrast?	N/A
N/A	Landing Slope (%)	N/A	N/A	DWS Length (in)	N/A
N/A	Landing X Slope (%)	N/A	N/A	DWS Full Width?	N/A
N/A	Landing Curb? (Y/N)	N/A	N/A	DWS Offset (in)	N/A
N/A	Shared Landing?	N/A			
N/A	Gutter Ponding?	N/A	N/A	Gutter Slope (%)	N/A
N/A	Gutter Lip Ht (in)	N/A	N/A	Gutter X Slope (%)	N/A
N/A	Painted X Walk1?	No	N/A	Painted X Walk2?	No
	X Walk 1 Direction	To S		X Walk 2 Direction	To SE
N/A	X Walk 1 Width (in)	N/A	N/A	X Walk 2 Width (in)	N/A
	X Walk 1 Slope (%)	0.4		X Walk 2 Slope (%)	0.5
	X Walk 1 X Slope (%)	2.4		X Walk 2 X Slope (%)	4.1

N/A	Ramp inside XWalk1?	N/A	N/A	Ramp inside XWalk2?	N/A
	Road Slope (%)	6.1	N/A	Clear Space?	N/A
	Road X Slope (%)	0.1	N/A	Clear Space to XWalk (in)	N/A
N/A	Any Obstructions?	N/A	N/A	Storm Grate/Utility Hazard?	N/A
	Obstruction Type			Storm Grate/Utility Type	
		N/A			N/A
		Yes		Surface Condition? (G/P)	Good

Possible Solutions:

**Remove & Replace Curb Ramp With Two New Directional Ramps or Equivalent.**

Total Cost: \$ 3200.00
