# Access Compliance Report

## Public Rights-of-Way

### (Curb Ramps)

Intersection ID: 10779	Main Street: AVIDXCHANGE_LN	Cross Street: HAMILTON_ST	Location: NW
ADA ID: 1AD4E7DD9C01	Ramp Type: Perp	Initial Pass/Fail: Fail	Overall Compliance: No
Severity Score: 8.75			
Codes/Mitigation Info/Possible Solution		Field Measurements/Component Compliance

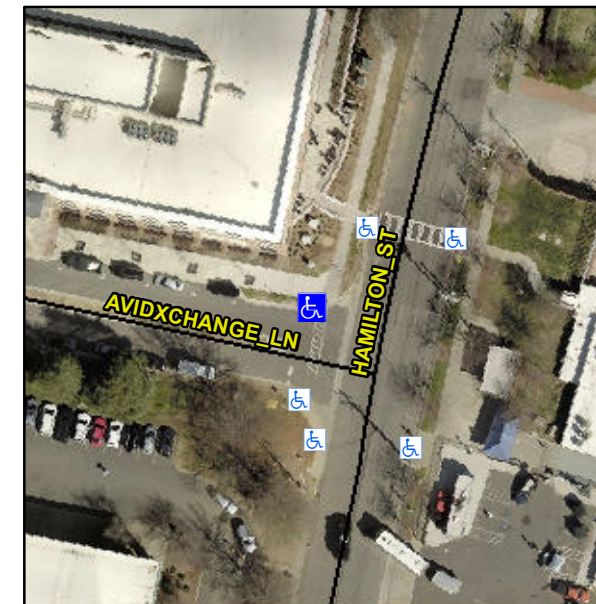
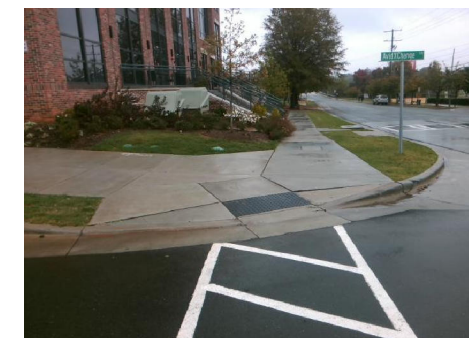
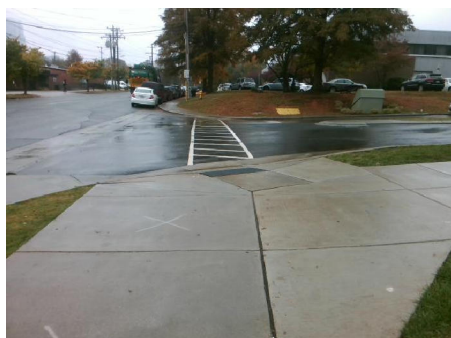
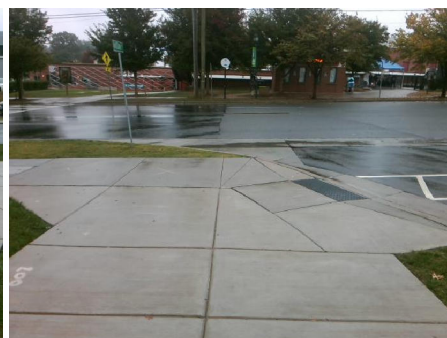
Compliance	Description	Data	Compliance	Description	Data
N/A	Ramp Length (in)	72.0	Yes	Ramp Slope (%)	8.0
No	Ramp Width (in)	47.5	Yes	Ramp XSlope (%)	0.7
N/A	Flare Type LT	N/A	N/A	Flare Type RT	N/A
N/A	Flare Slope LT (%)	N/A	N/A	Flare Slope RT (%)	N/A
N/A	Flare Traversable LT?	N/A	N/A	Flare Traversable RT?	N/A
N/A	Landing Length (in)	N/A	N/A	DWS Provided?	N/A
N/A	Landing Width (in)	N/A	N/A	DWS Contrast?	N/A
N/A	Landing Slope (%)	N/A	N/A	DWS Length (in)	N/A
N/A	Landing X Slope (%)	N/A	N/A	DWS Full Width?	N/A
N/A	Landing Curb? (Y/N)	N/A	N/A	DWS Offset (in)	N/A
N/A	Shared Landing?	N/A			
N/A	Gutter Ponding?	N/A	N/A	Gutter Slope (%)	N/A
N/A	Gutter Lip Ht (in)	N/A	N/A	Gutter X Slope (%)	N/A
N/A	Painted X Walk1?	Yes	N/A	Painted X Walk2?	N/A
	X Walk 1 Direction	To S		X Walk 2 Direction	N/A
N/A	X Walk 1 Width (in)	52.0	N/A	X Walk 2 Width (in)	N/A
	X Walk 1 Slope (%)	3.0		X Walk 2 Slope (%)	N/A
	X Walk 1 X Slope (%)	4.7		X Walk 2 X Slope (%)	N/A

N/A	Ramp inside XWalk1?	Yes	N/A	Ramp inside XWalk2?	N/A
	Road Slope (%)	N/A	N/A	Clear Space?	N/A
	Road X Slope (%)	N/A	N/A	Clear Space to XWalk (in)	N/A
N/A	Any Obstructions?	N/A	N/A	Storm Grate/Utility Hazard?	N/A
	Obstruction Type			Storm Grate/Utility Type	
		N/A			N/A
			Yes	Surface Condition? (G/P)	Good

Possible Solutions:

**Remove & Replace Entire Ramp.**

**Not Found, R304.5.1**

Total Cost: \$ 1850.00
