# Access Compliance Report

## Public Rights-of-Way

| Intersection ID: 45167 | Main Street: ARAGORN_LN | Cross Street: STRIDER_DR | Location: W |
| ADA ID: 1AE3FEF8DD89 | Ramp Type: PerpDiag | Initial Pass/Fail: Fail | Overall Compliance: No |

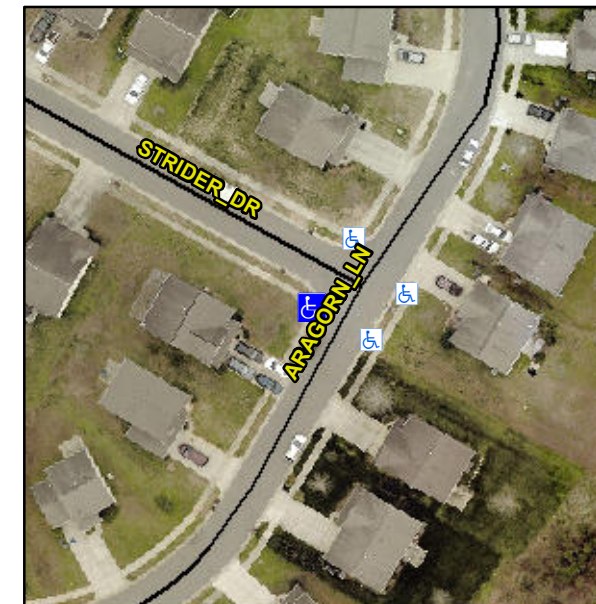
**R304.5.1, R304.5.3**

| Compliance | Description | Data | Compliance | Description | Data |
|---|---|---|---|---|---|
| N/A | Ramp Length (in) | 45.0 | Yes | Ramp Slope (%) | 8.2 |
| No | Ramp Width (in) | 33.0 | No | Ramp XSlope (%) | 2.6 |

**Remove & Replace Curb Ramp With Two New Directional Ramps or Equivalent.**

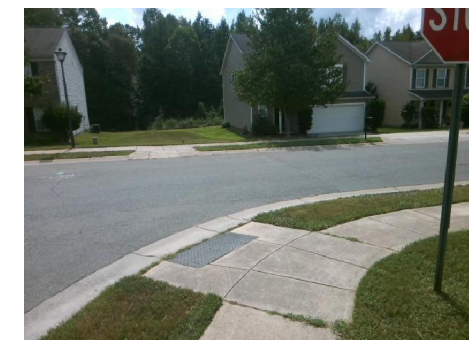
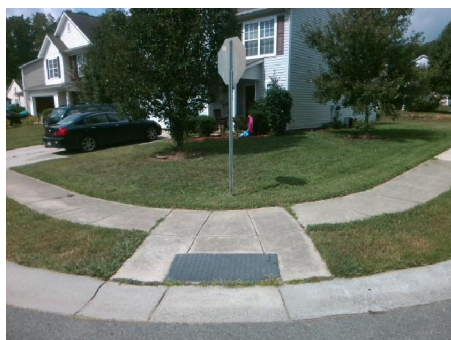
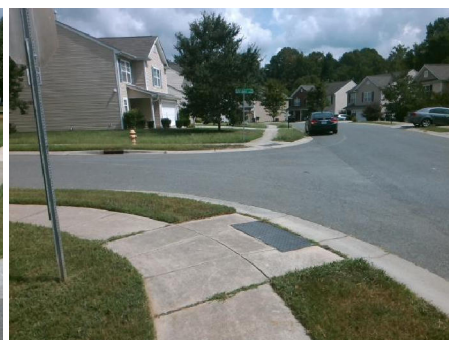
| Compliance | Description | Data | Compliance | Description | Data |
|---|---|---|---|---|---|
| | | | Yes | Surface Condition? (G/P) | Good |
