Access Compliance Report Public Rights-of-Way (Curb Ramps)

Intersection ID: 10038458 Main Street: SOUTHERN PINE BV **Cross Street: N/A** Location: NE **ADA ID: 1AFBF056E9F2** Ramp Type: PerpDiag Initial Pass/Fail: Fail **Overall Compliance: No Severity Score:** 25

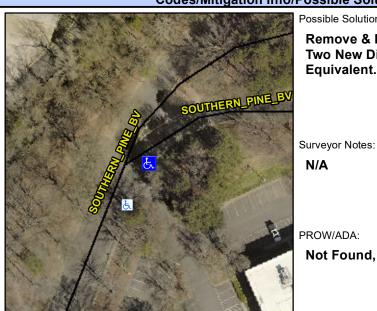
Compliance Description Data Compliance Description Data					
Compliance Description		Data			Data
N/A	Ramp Length (in)	48.0	No	Ramp Slope (%)	14.0
Yes	Ramp Width (in)	48.0	Yes	Ramp XSlope (%)	1.1
N/A	Flare Type LT	N/A	N/A	Flare Type RT	N/A
N/A	Flare Slope LT (%)	N/A	N/A	Flare Slope RT (%)	N/A
N/A	Flare Traversable LT?	N/A	N/A	Flare Traversable RT?	N/A
N/A	Landing Length (in)	N/A	N/A	DWS Provided?	N/A
N/A	Landing Width (in)	N/A	N/A	DWS Contrast?	N/A
N/A	Landing Slope (%)	N/A	N/A	DWS Length (in)	N/A
N/A	Landing X Slope (%)	N/A	N/A	DWS Full Width?	N/A
N/A	Landing Curb? (Y/N)	N/A	N/A	DWS Offset (in)	N/A
N/A	Shared Landing?	N/A			
N/A	Gutter Ponding?	N/A	N/A	Gutter Slope (%)	N/A
N/A	Gutter Lip Ht (in)	N/A	N/A	Gutter X Slope (%)	N/A
N/A	Painted X Walk1?	No	N/A	Painted X Walk2?	No
	X Walk 1 Direction	To W		X Walk 2 Direction	To S
N/A	X Walk 1 Width (in)	N/A	N/A	X Walk 2 Width (in)	N/A
	X Walk 1 Slope (%)	3.4		X Walk 2 Slope (%)	2.4

X Walk 1 X Slope (%)	3.6		X Walk 2 X Slope (%)	2.1
N/A	Ramp inside XWalk1?	N/A	N/A	Ramp inside XWalk2?	N/A
	Road Slope (%)	2.9	N/A	Clear Space?	N/A
	Road X Slope (%)	2.9	N/A	Clear Space to XWalk (in)	N/A
N/A	Any Obstructions?	N/A	N/A	Storm Grate/Utility Hazard?	N/A
	Obstruction Type			Storm Grate/Utility Type	
		N/A			N/A
			Yes	Surface Condition? (G/P)	Good

Possible Solutions: Remove & Replace Curb Ramp With Two New Directional Ramps or Equivalent.

Total Cost: 3200.00
