Access Compliance Report

Public Rights-of-Way

(Curb Ramps)

Intersection ID: 53750	Main Street: SPRINGWOOD_ESTATE_DR	Cross Street: SAGAMORE_HILL_DR	Location: SE
ADA ID: 1B04C6ECCC68	Ramp Type: Perp	Initial Pass/Fail: Fail	Overall Compliance: No
Severity Score: 33.75			
Codes/Mitigation Info/Possible Solution		Field Measurements/Component Compliance

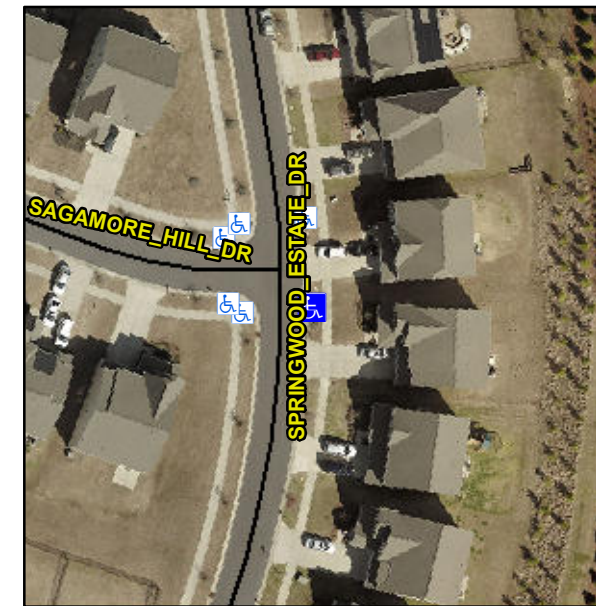
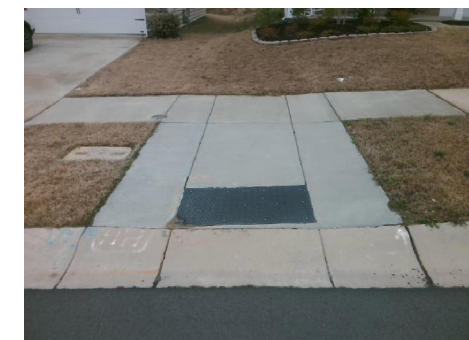
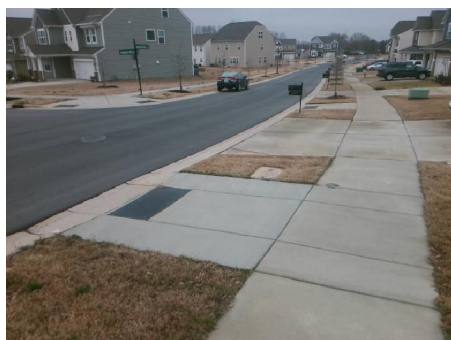
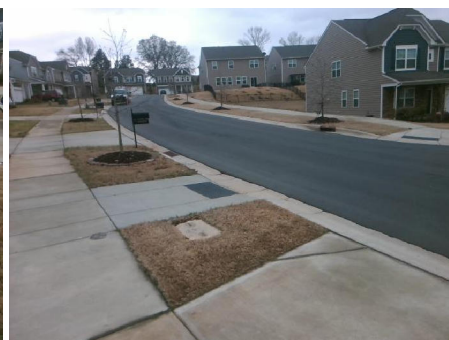
Not Found, R304.5.1, R304.5.3

Compliance	Description	Data	Compliance	Description	Data
N/A	Ramp Length (in)	95.0	Yes	Ramp Slope (%)	5.8
No	Ramp Width (in)	47.0	No	Ramp XSlope (%)	7.1
N/A	Flare Type LT	N/A	N/A	Flare Type RT	N/A
N/A	Flare Slope LT (%)	N/A	N/A	Flare Slope RT (%)	N/A
N/A	Flare Traversable LT?	N/A	N/A	Flare Traversable RT?	N/A
N/A	Landing Length (in)	N/A	N/A	DWS Provided?	N/A
N/A	Landing Width (in)	N/A	N/A	DWS Contrast?	N/A
N/A	Landing Slope (%)	N/A	N/A	DWS Length (in)	N/A
N/A	Landing X Slope (%)	N/A	N/A	DWS Full Width?	N/A
N/A	Landing Curb? (Y/N)	N/A	N/A	DWS Offset (in)	N/A
N/A	Shared Landing?	N/A			
N/A	Gutter Ponding?	N/A	N/A	Gutter Slope (%)	N/A
N/A	Gutter Lip Ht (in)	N/A	N/A	Gutter X Slope (%)	N/A
N/A	Painted X Walk1?	No	N/A	Painted X Walk2?	N/A
	X Walk 1 Direction	To W		X Walk 2 Direction	N/A
N/A	X Walk 1 Width (in)	N/A	N/A	X Walk 2 Width (in)	N/A
	X Walk 1 Slope (%)	1.2		X Walk 2 Slope (%)	N/A
	X Walk 1 X Slope (%)	3.7		X Walk 2 X Slope (%)	N/A

N/A	Ramp inside XWalk1?	N/A	N/A	Ramp inside XWalk2?	N/A
	Road Slope (%)	N/A	N/A	Clear Space?	N/A
	Road X Slope (%)	N/A	N/A	Clear Space to XWalk (in)	N/A
N/A	Any Obstructions?	N/A	N/A	Storm Grate/Utility Hazard?	N/A
	Obstruction Type			Storm Grate/Utility Type	
		N/A			N/A
			Yes	Surface Condition? (G/P)	Good

Remove & Replace Entire Ramp.
