Access Compliance Report

Public Rights-of-Way

(Curb Ramps)

Intersection ID: 18050	Main Street: S_TRYON_ST	Cross Street: SOUTHAMPTON_RD	Location: SW
ADA ID: 1B05333CA4A4	Ramp Type: Directional1	Initial Pass/Fail: Fail	Overall Compliance: No
		Severity Score: 1.25

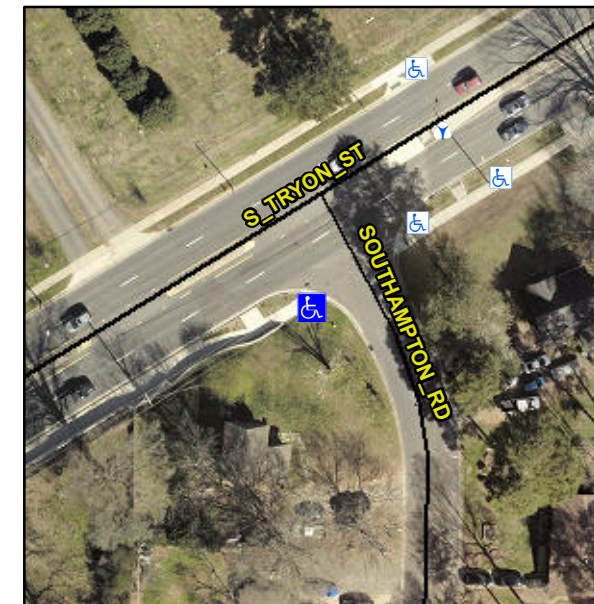
Compliance	Description	Data	Compliance	Description	Data
N/A	Ramp Length (in)	50.0	N/A	Grade Break?	N/A
Yes	Ramp Width (in)	78.0	N/A	Grade Break Slope (%)	0.0
Yes	Ramp Slope (%)	5.1	N/A	Grade Break XSlope (%)	0.0
No	Ramp XSlope (%)	3.0			
N/A	Flare Type LT	N/A	N/A	Flare Type RT	N/A
N/A	Flare Slope LT (%)	N/A	N/A	Flare Slope RT (%)	0.0
N/A	Flare Traversable LT?	N/A	N/A	Flare Traversable RT?	N/A
N/A	Landing Length (in)	0.0	N/A	DWS Provided?	N/A
N/A	Landing Width (in)	0.0	N/A	DWS Contrast?	N/A
N/A	Landing Slope (%)	0.0	N/A	DWS Length (in)	N/A
N/A	Landing X Slope (%)	0.0	N/A	DWS Full Width?	N/A
N/A	Landing Curb? (Y/N)	N/A	N/A	DWS Offset LT (in)	N/A
N/A	Shared Landing?	N/A	N/A	DWS Offset RT (in)	N/A
N/A	Gutter Ponding?	0.0	N/A	Gutter Slope (%)	N/A
N/A	Gutter Lip Ht (in)	0.0	N/A	Gutter X Slope (%)	N/A
N/A	Painted X Walk1?	No		Road Slope (%)	1.5
	X Walk 1 Direction	To NE		Road X Slope (%)	4.8
	X Walk 1 Width (in)	N/A		Clear Space?	N/A

X Walk 1 Slope (%)	1.5	N/A	Clear Space to XWalk (in)	N/A
	X Walk 1 X Slope (%)	4.8	N/A	Storm Grate/Utility Hazard?	N/A
N/A	Ramp inside XWalk1?	N/A		Storm Grate/Utility Type	
N/A	Any Obstructions?	N/A			N/A
	Obstruction Type		Yes	Surface Condition? (G/P)	Good
			N/A	Curb Slope (%)	4.8

Possible Solutions:

Remove & Replace Entire Ramp.

R304.5.3
