## Access Compliance Report Public Rights-of-Way (Curb Ramps)

Intersection ID: 6243 Main Street: BEATTIES\_FORD\_RD Cross Street: OLDE\_ENGLISH\_DR Location: SE

ADA ID: 1B147D9DDBC2 Ramp Type: Combination1 Initial Pass/Fail: Fail Overall Compliance: No Severity Score: 22.5

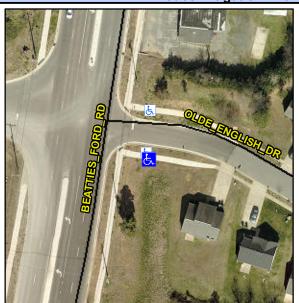
RT RP < 5%

Not Found, R304.5.1, R304.2.2, R304.5.3

Ramp XSlope LT (%) 4.4 No Ramp XSlope RT (%) No 3.1 N/A Ramp Length (in) 49.0 Nο Ramp Slope (%) 10.6 42.5 No Ramp XSlope (%) No Ramp Width (in) 4.7 N/A Flare Type LT N/A N/A Flare Type RT N/A N/A N/A Flare Slope LT (%) N/A Flare Slope RT (%) N/A N/A Flare Traversable LT? N/A N/A Flare Traversable RT? N/A N/A Landing Length (in) N/A N/A DWS Provided? N/A N/A N/A **DWS Contrast?** N/A Landing Width (in) N/A N/A Landing Slope (%) N/A N/A DWS Length (in) N/A N/A Landing X Slope (%) N/A N/A DWS Full Width? N/A N/A Landing Curb? (Y/N) N/A N/A DWS Offset (in) N/A N/A Shared Landing? N/A N/A Gutter Ponding? N/A N/A Gutter Slope (%) N/A N/A N/A Gutter Lip Ht (in) N/A Gutter X Slope (%) N/A N/A N/A Painted X Walk1? No Painted X Walk2? N/A To N X Walk 1 Direction X Walk 2 Direction N/A X Walk 1 Width (in) N/A X Walk 2 Width (in) N/A 2.9 X Walk 2 Slope (%) N/A X Walk 1 Slope (%) X Walk 1 X Slope (%) 2.1 X Walk 2 X Slope (%) N/A N/A Ramp inside XWalk1? N/A N/A Ramp inside XWalk2? N/A Road Slope (%) N/A Clear Space? N/A Road X Slope (%) N/A N/A Clear Space to XWalk (in) N/A N/A Any Obstruction? N/A **Obstruction Type** N/A N/A Storm Grate/Utility Hazard? N/A Storm Grate/Utility Type

Remove & Replace Entire Ramp.
