# Access Compliance Report

## Public Rights-of-Way

### (Curb Ramps)

| Intersection ID: 29339 | Main Street: NEVIN_BROOK_RD | Cross Street: NEVIN_RD | Location: W |

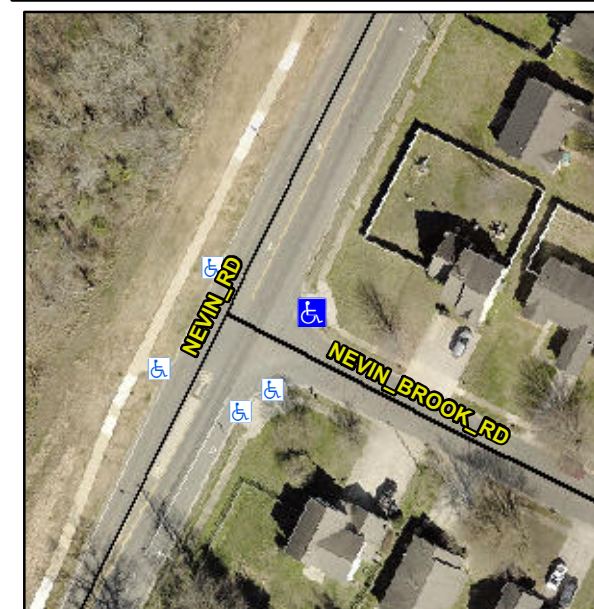
**Not Found, R304.5.3, R302.7.2**

| Compliance | Description | Data | Compliance | Description | Data |
|---|---|---|---|---|---|
| Yes | Ramp Width (in) | 48.0 | No | Ramp XSlope (%) | 2.6 |
| No | Gutter Lip Ht (in) | 1.0 | No | Gutter X Slope (%) | 5.6 |

**Remove & Replace Curb Ramp With Two New Directional Ramps or Equivalent. Remove & Replace Gutter.**
