Access Compliance Report

Public Rights-of-Way

(Curb Ramps)

Intersection ID: 27965	Main Street: BALLANTYNE_COUNTRY_CLUB_DR	Cross Street: POUND_HILL_LN	Location: SW
ADA ID: 1B2C359DDD74	Ramp Type: Perp	Initial Pass/Fail: Fail	Overall Compliance: No
Severity Score: 1.25			
Codes/Mitigation Info/Possible Solution		Field Measurements/Component Compliance

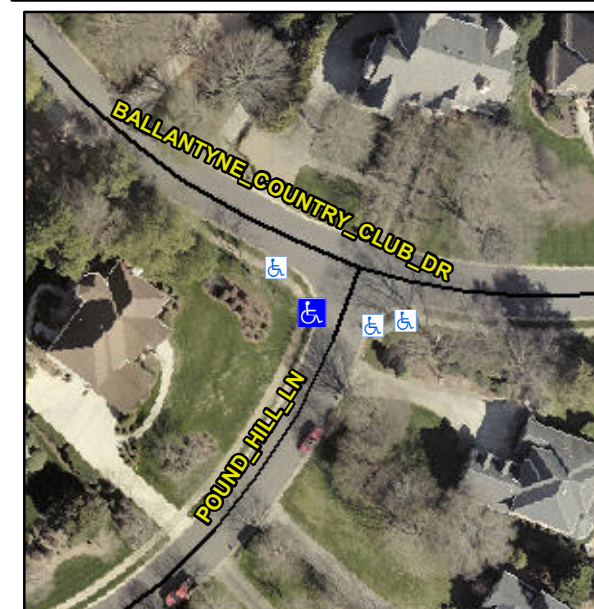
Not Found, R304.5.3

Compliance	Description	Data	Compliance	Description	Data
N/A	Ramp Length (in)	47.0	Yes	Ramp Slope (%)	5.3
Yes	Ramp Width (in)	48.0	No	Ramp XSlope (%)	2.5
N/A	Flare Type LT	N/A	N/A	Flare Type RT	N/A
N/A	Flare Slope LT (%)	N/A	N/A	Flare Slope RT (%)	N/A
N/A	Flare Traversable LT?	N/A	N/A	Flare Traversable RT?	N/A
N/A	Landing Length (in)	N/A	N/A	DWS Provided?	N/A
N/A	Landing Width (in)	N/A	N/A	DWS Contrast?	N/A
N/A	Landing Slope (%)	N/A	N/A	DWS Length (in)	N/A
N/A	Landing X Slope (%)	N/A	N/A	DWS Full Width?	N/A
N/A	Landing Curb? (Y/N)	N/A	N/A	DWS Offset (in)	N/A
N/A	Shared Landing?	N/A			
N/A	Gutter Ponding?	N/A	N/A	Gutter Slope (%)	N/A
N/A	Gutter Lip Ht (in)	N/A	N/A	Gutter X Slope (%)	N/A
N/A	Painted X Walk1?	No	N/A	Painted X Walk2?	N/A
	X Walk 1 Direction	To SE		X Walk 2 Direction	N/A
N/A	X Walk 1 Width (in)	N/A	N/A	X Walk 2 Width (in)	N/A
	X Walk 1 Slope (%)	2.2		X Walk 2 Slope (%)	N/A
	X Walk 1 X Slope (%)	2.8		X Walk 2 X Slope (%)	N/A

N/A	Ramp inside XWalk1?	N/A	N/A	Ramp inside XWalk2?	N/A
	Road Slope (%)	N/A	N/A	Clear Space?	N/A
	Road X Slope (%)	N/A	N/A	Clear Space to XWalk (in)	N/A
N/A	Any Obstructions?	N/A	N/A	Storm Grate/Utility Hazard?	N/A
	Obstruction Type			Storm Grate/Utility Type	
		N/A			N/A
			Yes	Surface Condition? (G/P)	Good

Remove & Replace Entire Ramp.

Total Cost: \$ 1850.00
