# Access Compliance Report

## Public Rights-of-Way

### (Curb Ramps)

Intersection ID: N/A	Main Street: STRAWBERRY_FIELDS_LN	Cross Street: MAGGIE_MAY_LN	Location: S
ADA ID: 1B2E37C47F14	Ramp Type: Perp	Initial Pass/Fail: Fail	Overall Compliance: No
Severity Score: 21.25			
Codes/Mitigation Info/Possible Solution		Field Measurements/Component Compliance

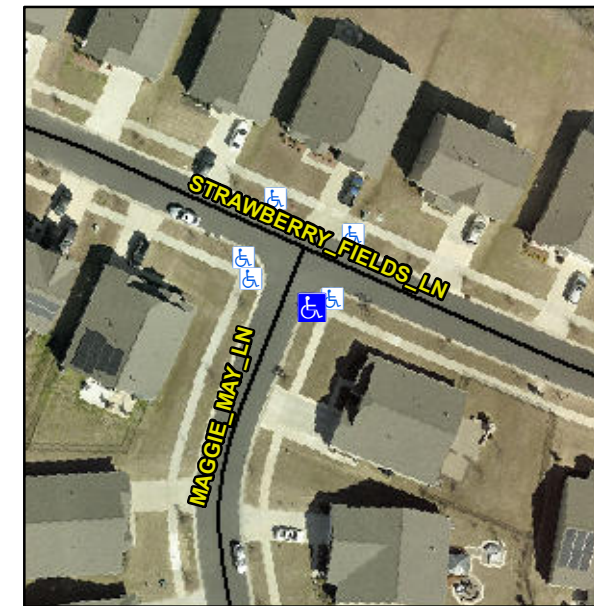
Compliance	Description	Data	Compliance	Description	Data
N/A	Ramp Length (in)	94.0	No	Ramp Slope (%)	9.9
No	Ramp Width (in)	46.0	Yes	Ramp XSlope (%)	0.4
N/A	Flare Type LT	N/A	N/A	Flare Type RT	N/A
N/A	Flare Slope LT (%)	N/A	N/A	Flare Slope RT (%)	N/A
N/A	Flare Traversable LT?	N/A	N/A	Flare Traversable RT?	N/A
N/A	Landing Length (in)	N/A	N/A	DWS Provided?	N/A
N/A	Landing Width (in)	N/A	N/A	DWS Contrast?	N/A
N/A	Landing Slope (%)	N/A	N/A	DWS Length (in)	N/A
N/A	Landing X Slope (%)	N/A	N/A	DWS Full Width?	N/A
N/A	Landing Curb? (Y/N)	N/A	N/A	DWS Offset (in)	N/A
N/A	Shared Landing?	N/A			
N/A	Gutter Ponding?	N/A	N/A	Gutter Slope (%)	N/A
N/A	Gutter Lip Ht (in)	N/A	N/A	Gutter X Slope (%)	N/A
N/A	Painted X Walk1?	No	N/A	Painted X Walk2?	N/A
	X Walk 1 Direction	To NW		X Walk 2 Direction	N/A
N/A	X Walk 1 Width (in)	N/A	N/A	X Walk 2 Width (in)	N/A
	X Walk 1 Slope (%)	0.5		X Walk 2 Slope (%)	N/A
	X Walk 1 X Slope (%)	1.3		X Walk 2 X Slope (%)	N/A

N/A	Ramp inside XWalk1?	N/A	N/A	Ramp inside XWalk2?	N/A
	Road Slope (%)	N/A	N/A	Clear Space?	N/A
	Road X Slope (%)	N/A	N/A	Clear Space to XWalk (in)	N/A
N/A	Any Obstructions?	N/A	N/A	Storm Grate/Utility Hazard?	N/A
	Obstruction Type			Storm Grate/Utility Type	
		N/A			N/A
			Yes	Surface Condition? (G/P)	Good

**Remove & Replace Entire Ramp.**

**R304.5.1, R304.2.2**
