Access Compliance Report

Public Rights-of-Way

(Curb Ramps)

| Intersection ID: 53165 | Main Street: DIXIE_RIVER_RD | Cross Street: N/A | Location: SW |

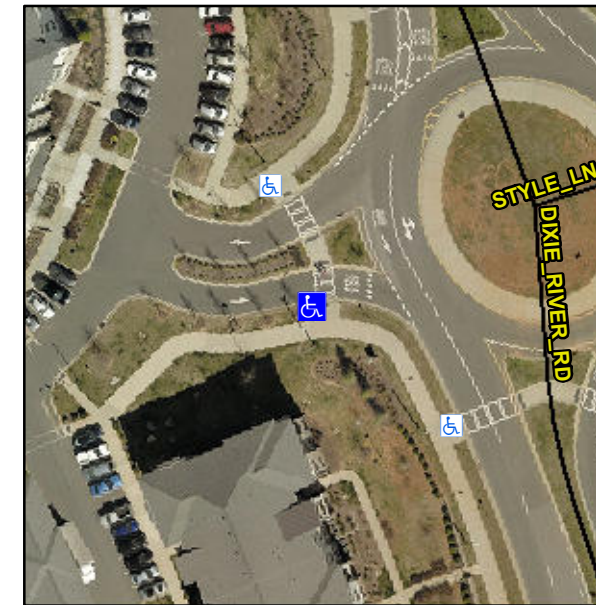
| ADA ID: 1B3D422ECA7A | Ramp Type: Perp | Initial Pass/Fail: Fail | Overall Compliance: No |

Not Found, R304.5.3

| Compliance | Description | Data | Compliance | Description | Data |
|---|---|---|---|---|---|
| Yes | Ramp Width (in) | 49.0 | No | Ramp XSlope (%) | 5.9 |

Remove & Replace Entire Ramp.
