Access Compliance Report

Public Rights-of-Way

(Curb Ramps)

| Intersection ID: 12937 | Main Street: E_W_T_HARRIS_BV | Cross Street: HICKORY_GROVE_RD | Location: NE |

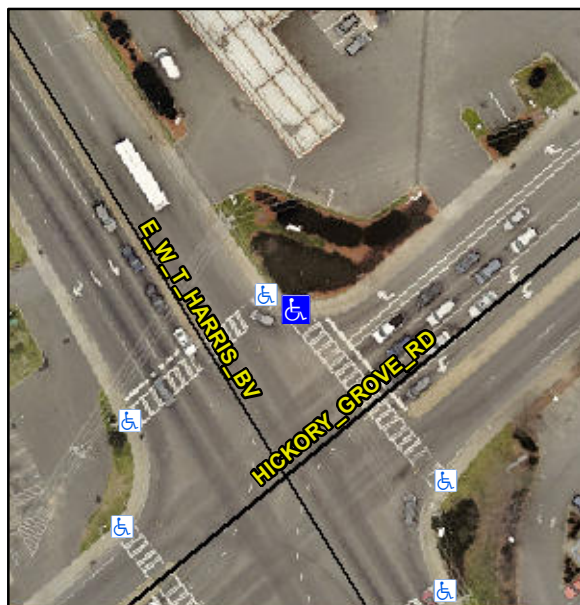
| ADA ID: 1B3D8B7BAF7D | Ramp Type: Perp | Initial Pass/Fail: Fail | Overall Compliance: No |
| Severity Score: 8.75 | | | |

Not Found, R304.5.1

| Compliance | Description | Data | Compliance | Description | Data |
|---|---|---|---|---|---|
| No | Ramp Width (in) | 47.5 | Yes | Ramp XSlope (%) | 1.1 |

Remove & Replace Entire Ramp.
