Access Compliance Report Public Rights-of-Way (Curb Ramps)

Intersection ID: 5407 Main Street: J_W_CLAY_BV Cross Street: J_M_KEYNES_DR Location: N

ADA ID: 1B411686D6C8 Ramp Type: Perp Initial Pass/Fail: Fail Overall Compliance: No Severity Score: 46.25

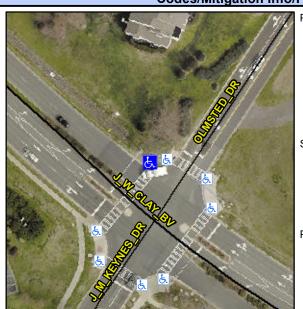
R304.5.1, R304.2.2, R304.5.3

No N/A Ramp Length (in) 94.0 Ramp Slope (%) 8.6 No Ramp XSlope (%) No Ramp Width (in) 47.0 7.7 N/A N/A Flare Type LT N/A Flare Type RT N/A N/A N/A N/A Flare Slope RT (%) N/A Flare Slope LT (%) N/A Flare Traversable LT? N/A N/A Flare Traversable RT? N/A N/A N/A N/A **DWS Provided?** N/A Landing Length (in) N/A Landing Width (in) N/A N/A **DWS Contrast?** N/A N/A N/A N/A Landing Slope (%) DWS Length (in) N/A N/A Landing X Slope (%) N/A N/A DWS Full Width? N/A N/A Landing Curb? (Y/N) N/A N/A DWS Offset (in) N/A N/A N/A Shared Landing? N/A **Gutter Ponding?** N/A N/A Gutter Slope (%) N/A N/A Gutter Lip Ht (in) N/A N/A Gutter X Slope (%) N/A N/A Painted X Walk1? No N/A Painted X Walk2? N/A X Walk 1 Direction To SW X Walk 2 Direction N/A N/A N/A N/A X Walk 1 Width (in) X Walk 2 Width (in) N/A X Walk 1 Slope (%) X Walk 2 Slope (%) N/A 1.3 X Walk 1 X Slope (%) 3.8 X Walk 2 X Slope (%) N/A N/A N/A N/A Ramp inside XWalk2? Ramp inside XWalk1? N/A Road Slope (%) N/A N/A Clear Space? N/A N/A Road X Slope (%) N/A Clear Space to XWalk (in) N/A N/A N/A Any Obstructions? N/A Storm Grate/Utility Hazard? N/A **Obstruction Type** Storm Grate/Utility Type N/A N/A Yes Surface Condition? (G/P) Good

Remove & Replace Entire Ramp.

Total Cost: \$ 1850.00
