Access Compliance Report

Public Rights-of-Way

(Curb Ramps)

Intersection ID: 28029	Main Street: BAY_HILL_CLUB_DR	Cross Street: PINE_VALLEY_CLUB_DR	Location: SW
ADA ID: 1B4C1618BA99	Ramp Type: Perp	Initial Pass/Fail: Pass	Overall Compliance: No
Codes/Mitigation Info/Possible Solution		Field Measurements/Component Compliance	
Severity Score: 15

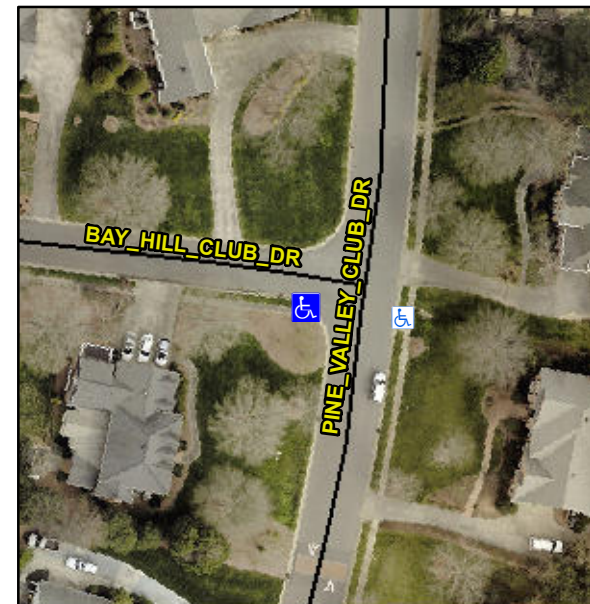
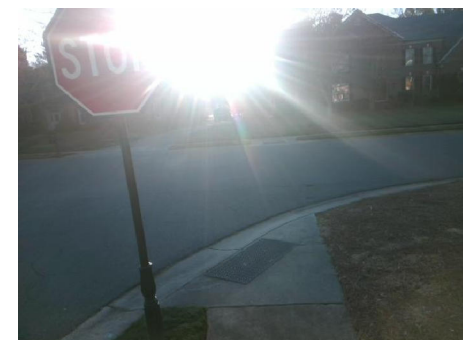
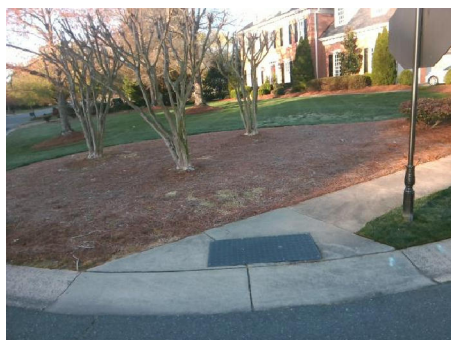
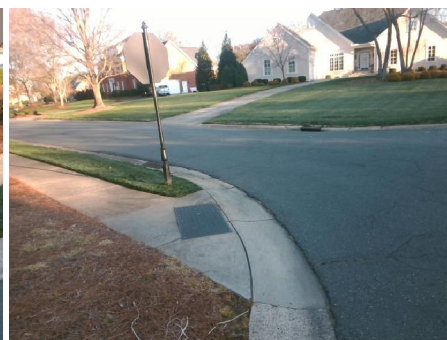
**Not Found, R304.2.1, R304.2.2-Perp,
R304.3.2-Para, R304.5.3, R302.7,
R304.5.4**

Compliance	Description	Data	Compliance	Description	Data
N/A	Ramp Length (in)	43.0	Yes	Ramp Slope (%)	5.1
Yes	Ramp Width (in)	48.0	Yes	Ramp XSlope (%)	0.9
N/A	Flare Type LT	Sloped	N/A	Flare Type RT	N/A
N/A	Flare Slope LT (%)	0.4	Yes	Flare Slope RT (%)	4.1
N/A	Flare Traversable LT?	Yes	N/A	Flare Traversable RT?	Yes
No	Landing Length (in)	N/A	Yes	DWS Provided?	Yes
No	Landing Width (in)	N/A	Yes	DWS Contrast?	Yes
No	Landing Slope (%)	N/A	Yes	DWS Length (in)	24.0
No	Landing X Slope (%)	N/A	Yes	DWS Full Width?	Yes
N/A	Landing Curb? (Y/N)	No	Yes	DWS Offset (in)	2.0
N/A	Shared Landing?	No			
No	Gutter Ponding?	Yes	No	Gutter Slope (%)	6.4
Yes	Gutter Lip Ht (in)	0.0	Yes	Gutter X Slope (%)	1.0
N/A	Painted X Walk1?	No	N/A	Painted X Walk2?	N/A
	X Walk 1 Direction	To SE		X Walk 2 Direction	N/A
N/A	X Walk 1 Width (in)	N/A	N/A	X Walk 2 Width (in)	N/A
	X Walk 1 Slope (%)	1.8		X Walk 2 Slope (%)	N/A
	X Walk 1 X Slope (%)	1.4		X Walk 2 X Slope (%)	N/A

N/A	Ramp inside XWalk1?	N/A	N/A	Ramp inside XWalk2?	N/A
	Road Slope (%)	N/A	N/A	Clear Space?	Yes
	Road X Slope (%)	N/A	N/A	Clear Space to XWalk (in)	N/A
Yes	Any Obstructions?	No	Yes	Storm Grate/Utility Hazard?	No
	Obstruction Type			Storm Grate/Utility Type	
		N/A			N/A
			Yes	Surface Condition? (G/P)	Good

**Remove & Replace Entire Ramp.
Remove & Replace Gutter.**

Total Cost: \$ **2600.00**
