Access Compliance Report

Public Rights-of-Way

(Curb Ramps)

Intersection ID: 49131	Main Street: EWERT_CUT_LN	Cross Street: WILTSHIRE_RIDGE_RD	Location: W
ADA ID: 1B4DBEB9EEA1	Ramp Type: Perp	Initial Pass/Fail: Fail	Overall Compliance: No
Severity Score: 21.25			
Codes/Mitigation Info/Possible Solution		Field Measurements/Component Compliance

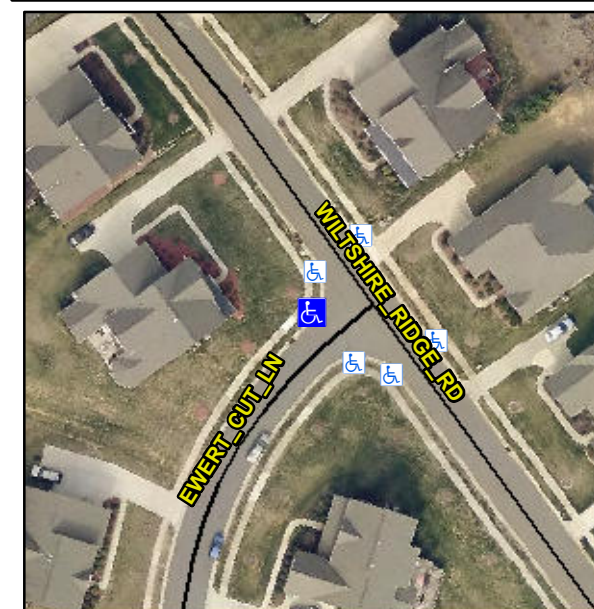
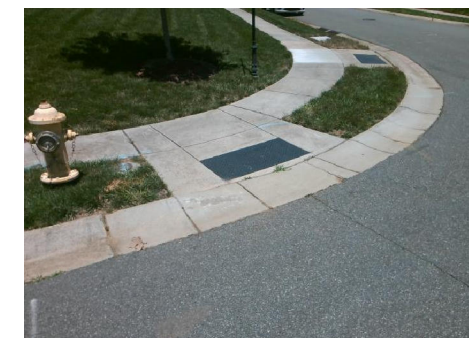
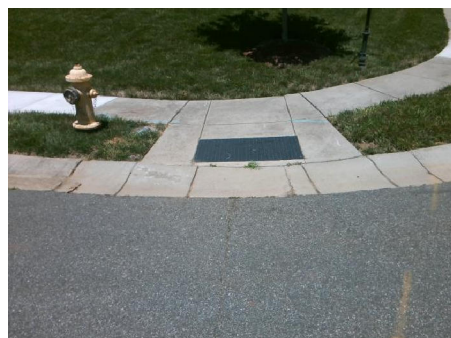
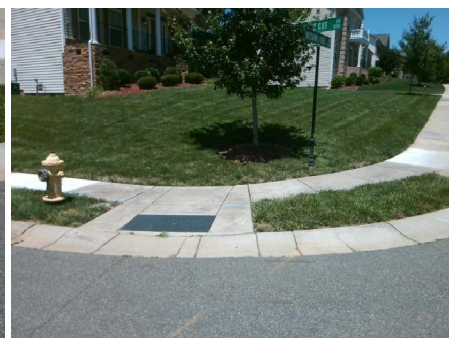
Compliance	Description	Data	Compliance	Description	Data
N/A	Ramp Length (in)	48.0	Yes	Ramp Slope (%)	6.3
No	Ramp Width (in)	44.0	No	Ramp XSlope (%)	5.4
N/A	Flare Type LT	N/A	N/A	Flare Type RT	N/A
N/A	Flare Slope LT (%)	N/A	N/A	Flare Slope RT (%)	N/A
N/A	Flare Traversable LT?	N/A	N/A	Flare Traversable RT?	N/A
N/A	Landing Length (in)	N/A	N/A	DWS Provided?	N/A
N/A	Landing Width (in)	N/A	N/A	DWS Contrast?	N/A
N/A	Landing Slope (%)	N/A	N/A	DWS Length (in)	N/A
N/A	Landing X Slope (%)	N/A	N/A	DWS Full Width?	N/A
N/A	Landing Curb? (Y/N)	N/A	N/A	DWS Offset (in)	N/A
N/A	Shared Landing?	N/A			
N/A	Gutter Ponding?	N/A	N/A	Gutter Slope (%)	N/A
N/A	Gutter Lip Ht (in)	N/A	N/A	Gutter X Slope (%)	N/A
N/A	Painted X Walk1?	No	N/A	Painted X Walk2?	N/A
	X Walk 1 Direction	To SE		X Walk 2 Direction	N/A
N/A	X Walk 1 Width (in)	N/A	N/A	X Walk 2 Width (in)	N/A
	X Walk 1 Slope (%)	0.3		X Walk 2 Slope (%)	N/A
	X Walk 1 X Slope (%)	2.3		X Walk 2 X Slope (%)	N/A

N/A	Ramp inside XWalk1?	N/A	N/A	Ramp inside XWalk2?	N/A
	Road Slope (%)	N/A	N/A	Clear Space?	N/A
	Road X Slope (%)	N/A	N/A	Clear Space to XWalk (in)	N/A
N/A	Any Obstructions?	N/A	N/A	Storm Grate/Utility Hazard?	N/A
	Obstruction Type			Storm Grate/Utility Type	
		N/A			N/A
		Yes		Surface Condition? (G/P)	Good

Possible Solutions:

Remove & Replace Entire Ramp.

PROW/ADA:

R304.5.1, R304.5.3
