Access Compliance Report Public Rights-of-Way (Curb Ramps)

Intersection ID: 21964 Main Street: CAMBRIDGE_CRESCENT_DR Cross Street: SHEFFIELD_CRESCENT_CT Location:

ADA ID: 1B4ECAFD0AA9 Ramp Type: Perp Initial Pass/Fail: Fail **Overall Compliance: No** Severity Score: 21.25

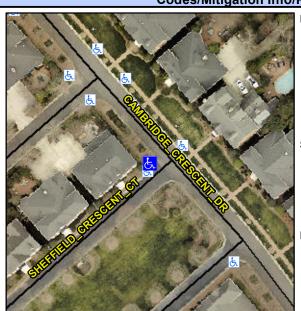
Field Measurements/Component Compliance						
Compl	liance Description	Data	Compl	iance	Description	Data
N/A	Ramp Length (in)	53.0	No	Ramp	Slope (%)	11.8
No	Ramp Width (in)	39.0	Yes	Ramp	xSlope (%)	1.6
N/A	Flare Type LT	N/A	N/A	Flare	Type RT	N/A
N/A	Flare Slope LT (%)	N/A	N/A	Flare	Slope RT (%)	N/A
N/A	Flare Traversable LT?	N/A	N/A	Flare	Traversable RT?	N/A
N/A	Landing Length (in)	N/A	N/A	DWS	Provided?	N/A
N/A	Landing Width (in)	N/A	N/A	DWS	Contrast?	N/A
N/A	Landing Slope (%)	N/A	N/A	DWS	Length (in)	N/A
N/A	Landing X Slope (%)	N/A	N/A	DWS	Full Width?	N/A
N/A	Landing Curb? (Y/N)	N/A	N/A	DWS	Offset (in)	N/A
N/A	Shared Landing?	N/A				
N/A	Gutter Ponding?	N/A	N/A	Gutte	er Slope (%)	N/A
N/A	Gutter Lip Ht (in)	1.0	N/A	Gutte	er X Slope (%)	N/A
N/A	Painted X Walk1?	No	N/A	Paint	ed X Walk2?	N/A
	X Walk 1 Direction	То Е		X Wa	lk 2 Direction	N/A
N/A	X Walk 1 Width (in)	N/A	N/A	X Wa	lk 2 Width (in)	N/A
	X Walk 1 Slope (%)	3.7		X Wa	lk 2 Slope (%)	N/A

X Walk 1 X Slope (%)	1.0		X Wa	lk 2 X Slope (%)	N/A
N/A	Ramp inside XWalk1?	N/A	N/A	Ram	o inside XWalk2?	N/A
	Road Slope (%)	N/A	N/A	Clear	Space?	N/A
	Road X Slope (%)	N/A	N/A	Clear	Space to XWalk (in)	N/A
N/A	Any Obstructions?	N/A	N/A	Storn	n Grate/Utility Hazard?	N/A
	Obstruction Type			Storn	n Grate/Utility Type	
		N/A				N/A
			Yes	Surfa	ce Condition? (G/P)	Good

Possible Solutions: Remove & Replace Entire Ramp. Surveyor Notes: N/A PROW/ADA: Not Found, R304.5.1, R304.2.2
