# Access Compliance Report

## Public Rights-of-Way

### (Curb Ramps)

Intersection ID: 26278	Main Street: BEVINGTON_PL	Cross Street: WESTBURY_WOODS_DR	Location: SE
ADA ID: 1B5B74A89139	Ramp Type: PerpDiag	Initial Pass/Fail: Fail	Overall Compliance: No
		Severity Score: 12.5

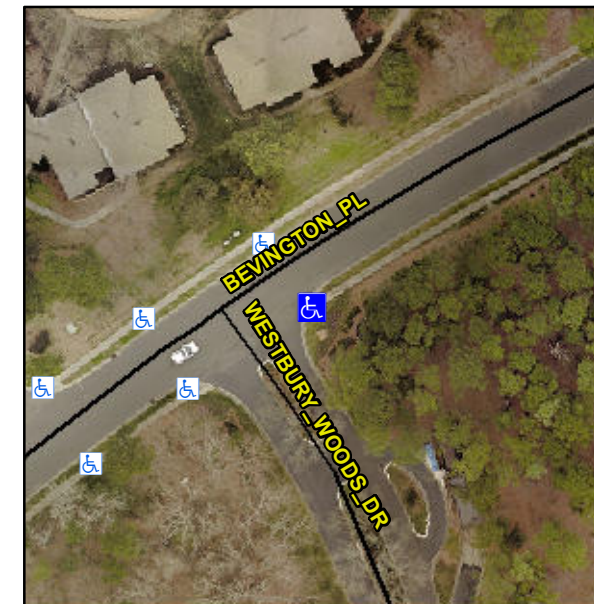
**Not Found, R304.5.3**

Compliance	Description	Data	Compliance	Description	Data
N/A	Ramp Length (in)	60.0	Yes	Ramp Slope (%)	7.9
Yes	Ramp Width (in)	48.0	No	Ramp XSlope (%)	5.7
N/A	Flare Type LT	N/A	N/A	Flare Type RT	N/A
N/A	Flare Slope LT (%)	N/A	N/A	Flare Slope RT (%)	N/A
N/A	Flare Traversable LT?	N/A	N/A	Flare Traversable RT?	N/A
N/A	Landing Length (in)	N/A	N/A	DWS Provided?	N/A
N/A	Landing Width (in)	N/A	N/A	DWS Contrast?	N/A
N/A	Landing Slope (%)	N/A	N/A	DWS Length (in)	N/A
N/A	Landing X Slope (%)	N/A	N/A	DWS Full Width?	N/A
N/A	Landing Curb? (Y/N)	N/A	N/A	DWS Offset (in)	N/A
N/A	Shared Landing?	N/A			
N/A	Gutter Ponding?	N/A	N/A	Gutter Slope (%)	N/A
N/A	Gutter Lip Ht (in)	N/A	N/A	Gutter X Slope (%)	N/A
N/A	Painted X Walk1?	No	N/A	Painted X Walk2?	No
	X Walk 1 Direction	To N		X Walk 2 Direction	To SW
N/A	X Walk 1 Width (in)	N/A	N/A	X Walk 2 Width (in)	N/A
	X Walk 1 Slope (%)	2.5		X Walk 2 Slope (%)	2.1
	X Walk 1 X Slope (%)	1.1		X Walk 2 X Slope (%)	6.9

N/A	Ramp inside XWalk1?	N/A	N/A	Ramp inside XWalk2?	N/A
	Road Slope (%)	6.0	N/A	Clear Space?	N/A
	Road X Slope (%)	4.7	N/A	Clear Space to XWalk (in)	N/A
N/A	Any Obstructions?	N/A	N/A	Storm Grate/Utility Hazard?	N/A
	Obstruction Type			Storm Grate/Utility Type	
		N/A			N/A
			Yes	Surface Condition? (G/P)	Good

**Remove & Replace Curb Ramp With Two New Directional Ramps or Equivalent.**
