Access Compliance Report

Public Rights-of-Way

(Curb Ramps)

| Intersection ID: 6527 | Main Street: FAIRES_FARM_RD | Cross Street: PAMELA_LORRAINE_DR | Location: NW |

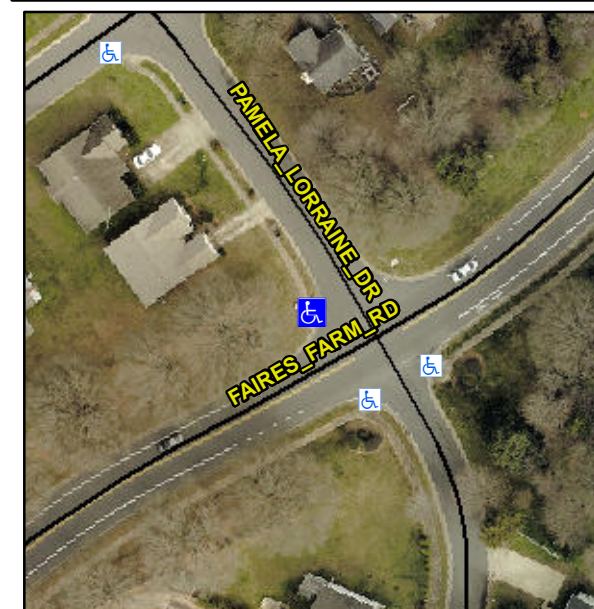
Not Found, R304.5.1, R304.5.3

| Compliance | Description | Data | Compliance | Description | Data |
|---|---|---|---|---|---|
| N/A | Ramp Length (in) | 48.0 | Yes | Ramp Slope (%) | 6.2 |
| No | Ramp Width (in) | 34.0 | No | Ramp XSlope (%) | 2.3 |

Remove & Replace Entire Ramp.
