# Access Compliance Report

## Public Rights-of-Way

### (Curb Ramps)

Intersection ID: 24485	Main Street: CAMAROSS_DR	Cross Street: SAINTFIELD_PL	Location: SE
ADA ID: 1B6D70E44690	Ramp Type: Perp	Initial Pass/Fail: Fail	Overall Compliance: No
		Severity Score: 12.5

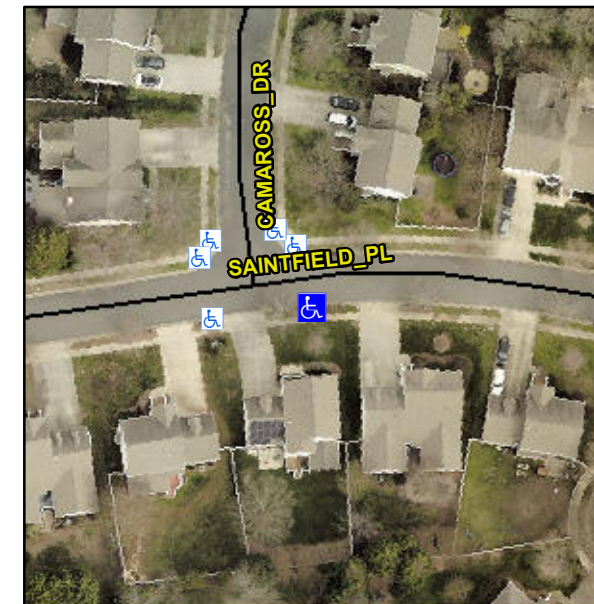
**Not Found, R304.2.2**

Compliance	Description	Data	Compliance	Description	Data
N/A	Ramp Length (in)	48.0	No	Ramp Slope (%)	8.7
Yes	Ramp Width (in)	48.0	Yes	Ramp XSlope (%)	0.4
N/A	Flare Type LT	N/A	N/A	Flare Type RT	N/A
N/A	Flare Slope LT (%)	N/A	N/A	Flare Slope RT (%)	N/A
N/A	Flare Traversable LT?	N/A	N/A	Flare Traversable RT?	N/A
N/A	Landing Length (in)	N/A	N/A	DWS Provided?	N/A
N/A	Landing Width (in)	N/A	N/A	DWS Contrast?	N/A
N/A	Landing Slope (%)	N/A	N/A	DWS Length (in)	N/A
N/A	Landing X Slope (%)	N/A	N/A	DWS Full Width?	N/A
N/A	Landing Curb? (Y/N)	N/A	N/A	DWS Offset (in)	N/A
N/A	Shared Landing?	N/A			
N/A	Gutter Ponding?	N/A	N/A	Gutter Slope (%)	N/A
N/A	Gutter Lip Ht (in)	N/A	N/A	Gutter X Slope (%)	N/A
N/A	Painted X Walk1?	No	N/A	Painted X Walk2?	N/A
	X Walk 1 Direction	To N		X Walk 2 Direction	N/A
N/A	X Walk 1 Width (in)	N/A	N/A	X Walk 2 Width (in)	N/A
	X Walk 1 Slope (%)	2.8		X Walk 2 Slope (%)	N/A
	X Walk 1 X Slope (%)	1.6		X Walk 2 X Slope (%)	N/A

**Remove & Replace Entire Ramp.**

Total Cost: \$ 1850.00
