Access Compliance Report

Public Rights-of-Way

(Curb Ramps)

Intersection ID: 8848	Main Street: N_TRYON_ST	Cross Street: WELLINGFORD_ST	Location: NW
ADA ID: 1B74F2F072F6	Ramp Type: PerpDiag	Initial Pass/Fail: Fail	Overall Compliance: No
		Severity Score: 35

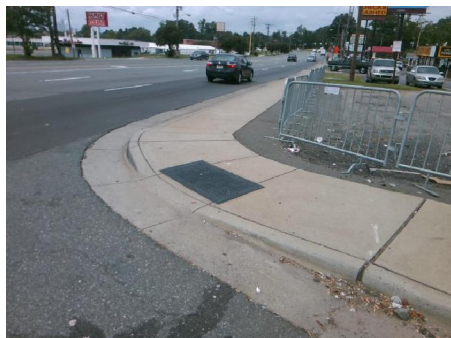
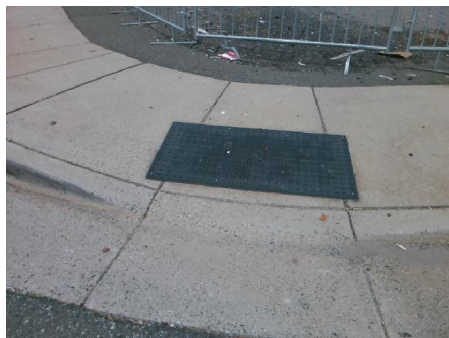
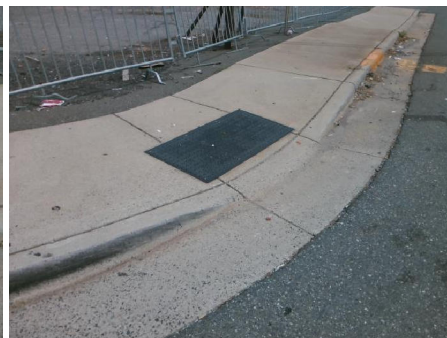
Compliance	Description	Data	Compliance	Description	Data
N/A	Ramp Length (in)	60.5	Yes	Ramp Slope (%)	6.2
No	Ramp Width (in)	28.0	Yes	Ramp XSlope (%)	1.0
N/A	Flare Type LT	N/A	N/A	Flare Type RT	N/A
N/A	Flare Slope LT (%)	N/A	N/A	Flare Slope RT (%)	N/A
N/A	Flare Traversable LT?	N/A	N/A	Flare Traversable RT?	N/A
N/A	Landing Length (in)	N/A	N/A	DWS Provided?	N/A
N/A	Landing Width (in)	N/A	N/A	DWS Contrast?	N/A
N/A	Landing Slope (%)	N/A	N/A	DWS Length (in)	N/A
N/A	Landing X Slope (%)	N/A	N/A	DWS Full Width?	N/A
N/A	Landing Curb? (Y/N)	N/A	N/A	DWS Offset (in)	N/A
N/A	Shared Landing?	N/A			
N/A	Gutter Ponding?	N/A	N/A	Gutter Slope (%)	N/A
N/A	Gutter Lip Ht (in)	1.0	N/A	Gutter X Slope (%)	N/A
N/A	Painted X Walk1?	No	N/A	Painted X Walk2?	No
	X Walk 1 Direction	To E		X Walk 2 Direction	To S
N/A	X Walk 1 Width (in)	N/A	N/A	X Walk 2 Width (in)	N/A
	X Walk 1 Slope (%)	1.9		X Walk 2 Slope (%)	3.2
	X Walk 1 X Slope (%)	2.1		X Walk 2 X Slope (%)	0.2

N/A	Ramp inside XWalk1?	N/A	N/A	Ramp inside XWalk2?	N/A
	Road Slope (%)	2.3	N/A	Clear Space?	N/A
	Road X Slope (%)	1.9	N/A	Clear Space to XWalk (in)	N/A
N/A	Any Obstructions?	N/A	N/A	Storm Grate/Utility Hazard?	N/A
	Obstruction Type			Storm Grate/Utility Type	
		N/A			N/A
			Yes	Surface Condition? (G/P)	Good

Remove & Replace Curb Ramp With Two New Directional Ramps or Equivalent.
