Access Compliance Report Public Rights-of-Way (Curb Ramps)

Intersection ID: 20986Main Street:W_ARROWOOD_RDCross Street: ARROWPOINT_BVLocation:NEADA ID: 1B773054AC51Ramp Type:PerpDiagInitial Pass/Fail: FailOverall Compliance: NoSeverity Score:26.25

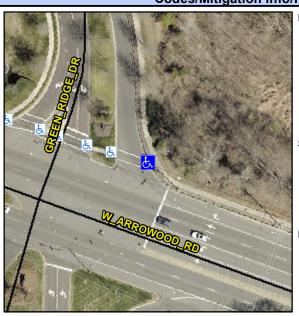
Not Found, R304.2.2

Compliance Description		Data	Compliance Description		Data
N/A	Ramp Length (in)	47.0	No	Ramp Slope (%)	15.2
Yes	Ramp Width (in)	48.0	Yes	Ramp XSlope (%)	3.2
N/A	Flare Type LT	N/A	N/A	Flare Type RT	N/A
N/A	Flare Slope LT (%)	N/A	N/A	Flare Slope RT (%)	N/A
N/A	Flare Traversable LT?	N/A	N/A	Flare Traversable RT?	N/A
N/A	Landing Length (in)	N/A	N/A	DWS Provided?	N/A
N/A	Landing Width (in)	N/A	N/A	DWS Contrast?	N/A
N/A	Landing Slope (%)	N/A	N/A	DWS Length (in)	N/A
N/A	Landing X Slope (%)	N/A	N/A	DWS Full Width?	N/A
N/A	Landing Curb? (Y/N)	N/A	N/A	DWS Offset (in)	N/A
N/A	Shared Landing?	N/A			
N/A	Gutter Ponding?	N/A	N/A	Gutter Slope (%)	N/A
N/A	Gutter Lip Ht (in)	N/A	N/A	Gutter X Slope (%)	N/A
N/A	Painted X Walk1?	Yes	N/A	Painted X Walk2?	No
	X Walk 1 Direction	To NW		X Walk 2 Direction	To SW
N/A	X Walk 1 Width (in)	100.0	N/A	X Walk 2 Width (in)	N/A
	X Walk 1 Slope (%)	3.5		X Walk 2 Slope (%)	0.5
	X Walk 1 X Slope (%)	0.9		X Walk 2 X Slope (%)	2.7

Remove & Replace Curb Ramp With Two New Directional Ramps or Equivalent.
