Access Compliance Report

Public Rights-of-Way

(Curb Ramps)

Intersection ID: 14757	Main Street: E_WORTHINGTON_AV	Cross Street: LENNOX_AV	Location: S
ADA ID: 1B795D6C7E9D	Ramp Type: Perp	Initial Pass/Fail: Fail	Overall Compliance: No
Severity Score: 1.25			
Codes/Mitigation Info/Possible Solution		Field Measurements/Component Compliance

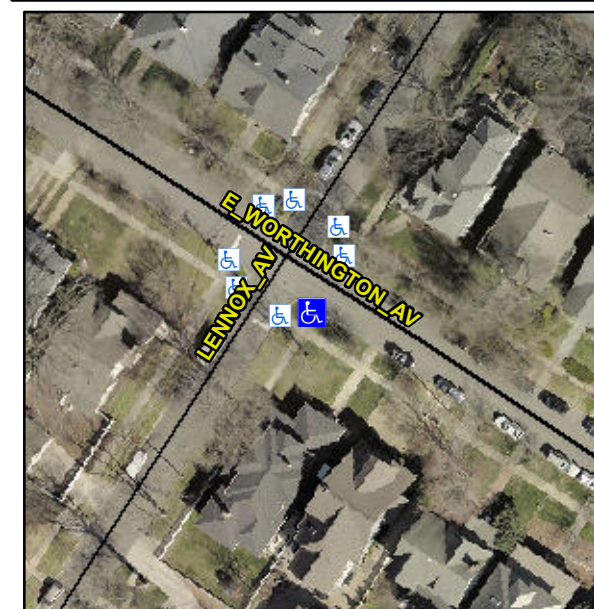
R304.5.3

Compliance	Description	Data	Compliance	Description	Data
N/A	Ramp Length (in)	111.0	Yes	Ramp Slope (%)	5.8
Yes	Ramp Width (in)	57.0	No	Ramp XSlope (%)	2.8
N/A	Flare Type LT	N/A	N/A	Flare Type RT	N/A
N/A	Flare Slope LT (%)	N/A	N/A	Flare Slope RT (%)	N/A
N/A	Flare Traversable LT?	N/A	N/A	Flare Traversable RT?	N/A
N/A	Landing Length (in)	N/A	N/A	DWS Provided?	N/A
N/A	Landing Width (in)	N/A	N/A	DWS Contrast?	N/A
N/A	Landing Slope (%)	N/A	N/A	DWS Length (in)	N/A
N/A	Landing X Slope (%)	N/A	N/A	DWS Full Width?	N/A
N/A	Landing Curb? (Y/N)	N/A	N/A	DWS Offset (in)	N/A
N/A	Shared Landing?	N/A			
N/A	Gutter Ponding?	N/A	N/A	Gutter Slope (%)	N/A
N/A	Gutter Lip Ht (in)	1.0	N/A	Gutter X Slope (%)	N/A
N/A	Painted X Walk1?	No	N/A	Painted X Walk2?	N/A
	X Walk 1 Direction	To NE		X Walk 2 Direction	N/A
N/A	X Walk 1 Width (in)	N/A	N/A	X Walk 2 Width (in)	N/A
	X Walk 1 Slope (%)	4.5		X Walk 2 Slope (%)	N/A
	X Walk 1 X Slope (%)	0.6		X Walk 2 X Slope (%)	N/A

N/A	Ramp inside XWalk1?	N/A	N/A	Ramp inside XWalk2?	N/A
	Road Slope (%)	N/A	N/A	Clear Space?	N/A
	Road X Slope (%)	N/A	N/A	Clear Space to XWalk (in)	N/A
N/A	Any Obstructions?	N/A	N/A	Storm Grate/Utility Hazard?	N/A
	Obstruction Type			Storm Grate/Utility Type	
		N/A			N/A
			Yes	Surface Condition? (G/P)	Good

Possible Solutions:

Remove & Replace Entire Ramp.

\$ 1850.00
