Access Compliance Report Public Rights-of-Way (Curb Ramps)

_					
Intersection ID: 45438 Main S	Main Street: HENDERSON_VALLEY_LN		Cross Street: HENDERSON_CR			Location:	SW
ADA ID: 1B7A20113803 Ramp	DA ID: 1B7A20113803 Ramp Type: Perp		Initial Pass/Fail: Fail Overall Compliance: No			Severity Score:	35
Codes/Mitigation Info/Possible Solution		Field Measurements/Component Compliance					
	Possible Solutions:	Com	bliance Description	Data	Comp	liance Description	Data
A State of the second sec	Remove & Replace Entire Ramp.	N/A	Ramp Length (in)	49.0	No	Ramp Slope (%)	20.0
1 Maria and a second		No	Ramp Width (in)	43.0	No	Ramp XSlope (%)	4.2
	3	N/A	Flare Type LT	N/A	N/A	Flare Type RT	N/A
HENDERSON VALUEY IN	de la constance	N/A	Flare Slope LT (%)	N/A	N/A	Flare Slope RT (%)	N/A
		N/A	Flare Traversable LT?	N/A	N/A	Flare Traversable RT?	N/A
		N/A	Landing Length (in)	N/A	N/A	DWS Provided?	N/A
	Surveyor Notes:	N/A	Landing Width (in)	N/A	N/A	DWS Contrast?	N/A
	N/A	N/A	Landing Slope (%)	N/A	N/A	DWS Length (in)	N/A

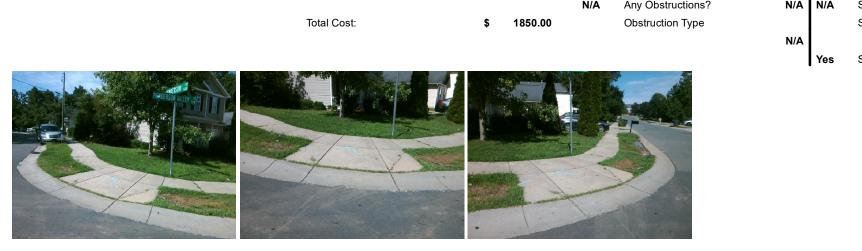
N/A	Landing X Slope (%)	N/A	N/A	DWS Full Width?	N/A
		N/A	Landing Curb? (Y/N)	N/A	N/A	DWS Offset (in)	N/A
	5	N/A	Shared Landing?	N/A			
	PROW/ADA:	N/A	Gutter Ponding?	N/A	N/A	Gutter Slope (%)	N/A
	Not Found, R304.5.1, R304.2.2,	N/A	Gutter Lip Ht (in)	N/A	N/A	Gutter X Slope (%)	N/A
	R304.5.3	N/A	Painted X Walk1?	No	N/A	Painted X Walk2?	N/A
			X Walk 1 Direction	To N		X Walk 2 Direction	N/A
		N/A	X Walk 1 Width (in)	N/A	N/A	X Walk 2 Width (in)	N/A
Street 1 Name HENDERSON VALLEY LN	_		X Walk 1 Slope (%)	4.6		X Walk 2 Slope (%)	N/A
Stop Condition-Street 2 None			X Walk 1 X Slope (%)	0.5		X Walk 2 X Slope (%)	N/A
Street 2 Name N/A		N/A	Ramp inside XWalk1?	N/A	N/A	Ramp inside XWalk2?	N/A
Stop Condition-Street 1 N/A			Road Slope (%)	N/A	N/A	Clear Space?	N/A
			Road X Slope (%)	N/A	N/A	Clear Space to XWalk (in)	N/A
		N/A	Any Obstructions?	N/A	N/A	Storm Grate/Utility Hazard?	N/A
	Total Cost: \$ 1	850.00	Obstruction Type			Storm Grate/Utility Type
