Access Compliance Report Public Rights-of-Way (Curb Ramps)

Intersection ID: 10022902 Main Street: CAYMAN WY **Cross Street: N/A** Location: N **Overall Compliance: No** ADA ID: 1B80C3996FD6 Ramp Type: Perp Initial Pass/Fail: Fail **Severity Score:** 22.5

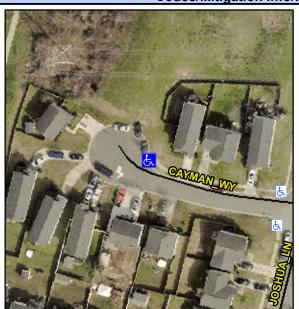
Field Measurements/Component Compliance

47.0 No

No

Possible Solutions:									
Remove & Replace Entire Ramp.									
Surveyor Notes:									
N/A									
PROW/ADA:									
Not Found, R304.5.1, R304.2.2, R304.5.3									
11004.0.0
