Access Compliance Report Public Rights-of-Way (Curb Ramps)

Intersection ID: 25770 Main Street: PINEVILLE-MATTHEWS RD **Cross Street: MCMAHAN DR** Location: NW ADA ID: 1B8410A29785 Ramp Type: PerpDiag Initial Pass/Fail: Fail **Overall Compliance: No** Severity Score: 13.75

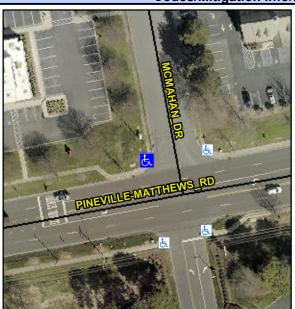
Field Measurements/Component Compliance Compliance Description Data Compliance Description Data					
N/A		58.0	No		8.5
n/A Yes	Ramp Length (in)	48.0	No	Ramp Slope (%)	o.5 2.5
	Ramp Width (in)			Ramp XSlope (%)	
N/A	Flare Type LT	N/A	N/A	Flare Type RT	N/A
N/A	Flare Slope LT (%)	N/A	N/A	Flare Slope RT (%)	N/A
N/A	Flare Traversable LT?	N/A	N/A	Flare Traversable RT?	N/A
N/A	Landing Length (in)	N/A	N/A	DWS Provided?	N/A
N/A	Landing Width (in)	N/A	N/A	DWS Contrast?	N/A
N/A	Landing Slope (%)	N/A	N/A	DWS Length (in)	N/A
N/A	Landing X Slope (%)	N/A	N/A	DWS Full Width?	N/A
N/A	Landing Curb? (Y/N)	N/A	N/A	DWS Offset (in)	N/A
N/A	Shared Landing?	N/A			
N/A	Gutter Ponding?	N/A	N/A	Gutter Slope (%)	N/A
N/A	Gutter Lip Ht (in)	N/A	N/A	Gutter X Slope (%)	N/A
N/A	Painted X Walk1?	No	N/A	Painted X Walk2?	No
	X Walk 1 Direction	To S		X Walk 2 Direction	To E
N/A	X Walk 1 Width (in)	N/A	N/A	X Walk 2 Width (in)	N/A
	X Walk 1 Slope (%)	2.3		X Walk 2 Slope (%)	1.1

X Walk 1 X Slope (%)	2.7		X Walk 2 X Slope (%)	2.0
N/A	Ramp inside XWalk1?	N/A	N/A	Ramp inside XWalk2?	N/A
	Road Slope (%)	3.0	N/A	Clear Space?	N/A
	Road X Slope (%)	0.4	N/A	Clear Space to XWalk (in)	N/A
N/A	Any Obstructions?	N/A	N/A	Storm Grate/Utility Hazard?	N/A
	Obstruction Type			Storm Grate/Utility Type

Possible Solutions: Remove & Replace Curb Ramp With Two New Directional Ramps or Equivalent. Surveyor Notes: N/A PROW/ADA: Not Found, R304.2.2, R304.5.3
