# Access Compliance Report

## Public Rights-of-Way (Curb Ramps)

Intersection ID: 50041	Main Street: METROPOLITAN_AV	Cross Street: CHARLOTTETOWNE_AV	Location: SE
ADA ID: 1B891A3D0887	Ramp Type: Directional1	Initial Pass/Fail: Fail	Overall Compliance: No
			Severity Score: 13.75

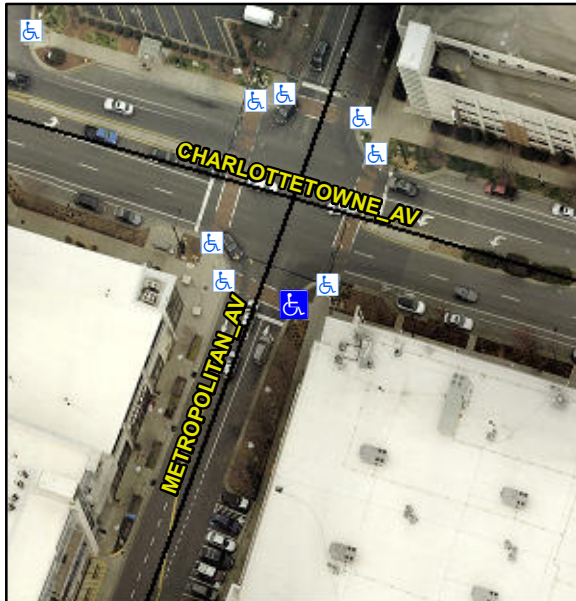
Compliance	Description	Data	Compliance	Description	Data
N/A	Ramp Length (in)	92.5	N/A	Grade Break?	N/A
Yes	Ramp Width (in)	95.0	N/A	Grade Break Slope (%)	0.0
No	Ramp Slope (%)	8.9	N/A	Grade Break XSlope (%)	0.0
No	Ramp XSlope (%)	3.1			
N/A	Flare Type LT	N/A	N/A	Flare Type RT	N/A
N/A	Flare Slope LT (%)	N/A	N/A	Flare Slope RT (%)	0.0
N/A	Flare Traversable LT?	N/A	N/A	Flare Traversable RT?	N/A
N/A	Landing Length (in)	0.0	N/A	DWS Provided?	N/A
N/A	Landing Width (in)	0.0	N/A	DWS Contrast?	N/A
N/A	Landing Slope (%)	0.0	N/A	DWS Length (in)	N/A
N/A	Landing X Slope (%)	0.0	N/A	DWS Full Width?	N/A
N/A	Landing Curb? (Y/N)	N/A	N/A	DWS Offset LT (in)	N/A
N/A	Shared Landing?	N/A	N/A	DWS Offset RT (in)	N/A
N/A	Gutter Ponding?	0.0	N/A	Gutter Slope (%)	N/A
N/A	Gutter Lip Ht (in)	0.0	N/A	Gutter X Slope (%)	N/A
N/A	Painted X Walk1?	Yes		Road Slope (%)	1.6
	X Walk 1 Direction	To NW		Road X Slope (%)	0.9
	X Walk 1 Width (in)	98.0		Clear Space?	N/A

X Walk 1 Slope (%)	1.6	N/A	Clear Space to XWalk (in)	N/A
	X Walk 1 X Slope (%)	0.9	N/A	Storm Grate/Utility Hazard?	N/A
N/A	Ramp inside XWalk1?	Yes		Storm Grate/Utility Type	
N/A	Any Obstructions?	N/A			N/A
	Obstruction Type		Yes	Surface Condition? (G/P)	Good
			N/A	Curb Slope (%)	7.2

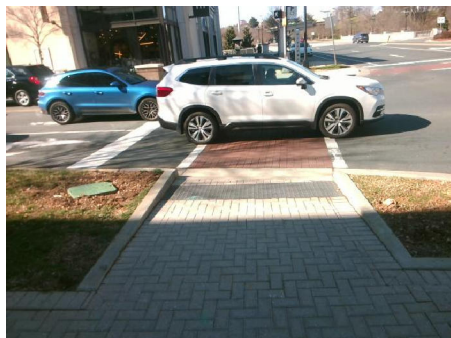
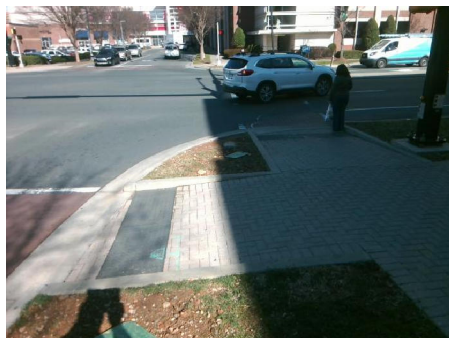
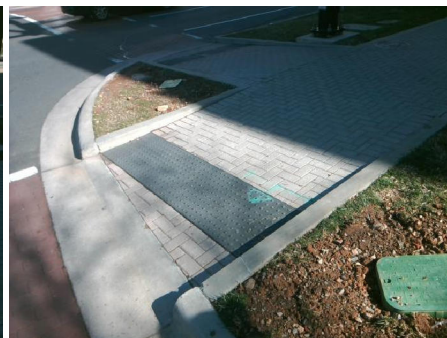
Surveyor Notes:

**XWALK PAVERS**

PROW/ADA:

**R304.2.2, R304.5.3**

Possible Solutions:

**Remove & Replace Entire Ramp.**
