# Access Compliance Report

## Public Rights-of-Way

### (Curb Ramps)

| Intersection ID: 14183 | Main Street: WEST_BV | Cross Street: OLD_STEELE_CREEK_RD | Location: SE |

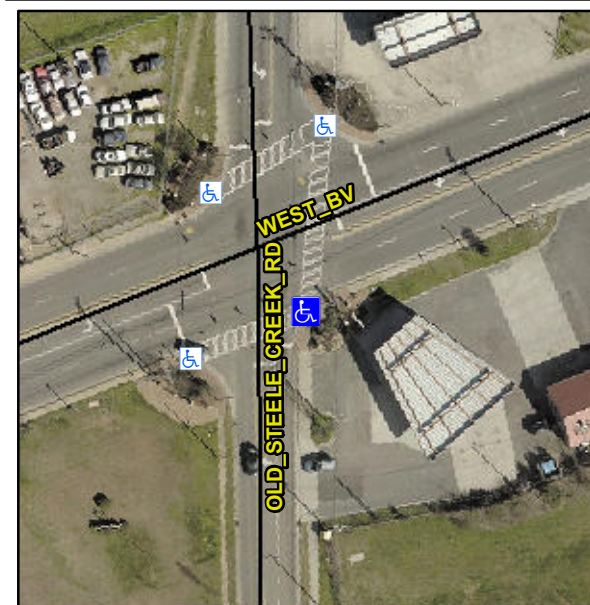
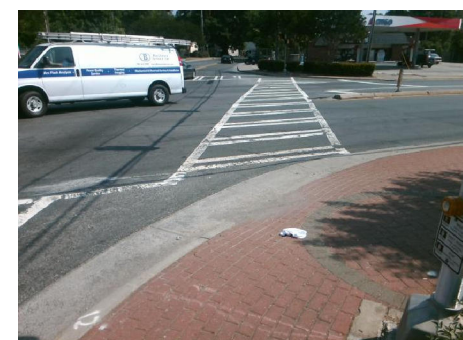
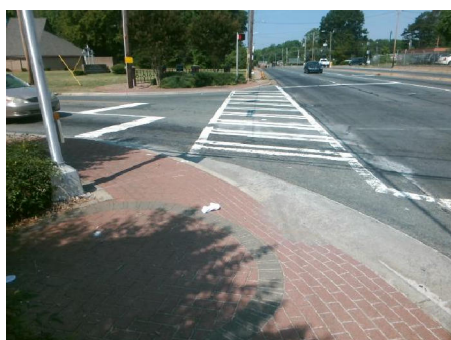
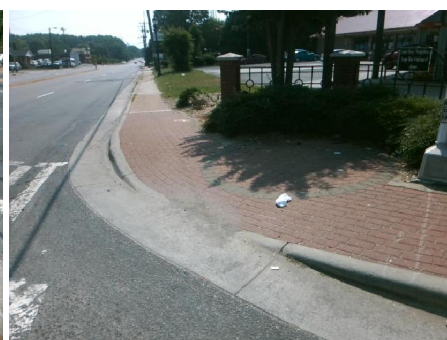
| ADA ID: 1B896D63C462 | Ramp Type: PerpDiag | Initial Pass/Fail: Fail | Overall Compliance: No |
| Severity Score: 13.75 | | | |

**R304.2.2, R304.5.3**

| Compliance | Description | Data | Compliance | Description | Data |
|---|---|---|---|---|---|
| N/A | Ramp Length (in) | 77.0 | No | Ramp Slope (%) | 8.9 |
| Yes | Ramp Width (in) | 70.0 | No | Ramp XSlope (%) | 3.7 |

**Remove & Replace Curb Ramp With Two New Directional Ramps or Equivalent.**

Total Cost: \$ 3200.00
