# Access Compliance Report

## Public Rights-of-Way

### (Curb Ramps)

Intersection ID: 52442	Main Street: WOODWARD_AV	Cross Street: BENDING_BIRCH_PL	Location: NW
ADA ID: 1B9B9D34B999	Ramp Type: Directional1	Initial Pass/Fail: Fail	Overall Compliance: No
		Severity Score: 50

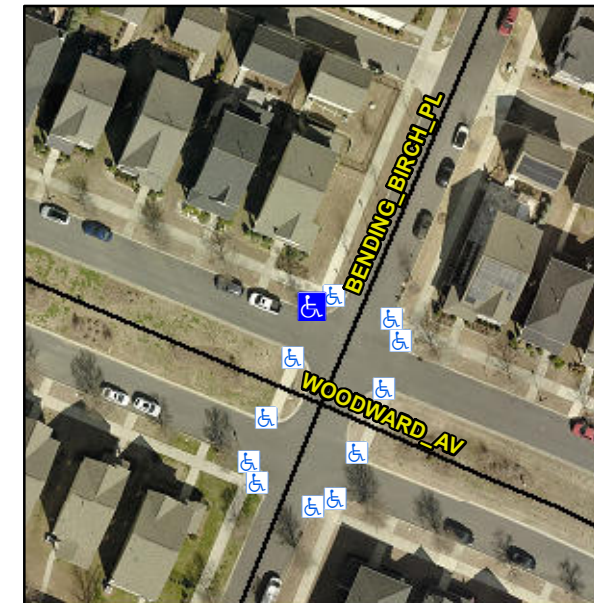
Compliance	Description	Data	Compliance	Description	Data
N/A	Ramp Length (in)	84.5	N/A	Grade Break?	N/A
Yes	Ramp Width (in)	62.0	N/A	Grade Break Slope (%)	0.0
No	Ramp Slope (%)	14.4	N/A	Grade Break XSlope (%)	0.0
No	Ramp XSlope (%)	7.6			
N/A	Flare Type LT	N/A	N/A	Flare Type RT	N/A
N/A	Flare Slope LT (%)	N/A	N/A	Flare Slope RT (%)	0.0
N/A	Flare Traversable LT?	N/A	N/A	Flare Traversable RT?	N/A
N/A	Landing Length (in)	0.0	N/A	DWS Provided?	N/A
N/A	Landing Width (in)	0.0	N/A	DWS Contrast?	N/A
N/A	Landing Slope (%)	0.0	N/A	DWS Length (in)	N/A
N/A	Landing X Slope (%)	0.0	N/A	DWS Full Width?	N/A
N/A	Landing Curb? (Y/N)	N/A	N/A	DWS Offset LT (in)	N/A
N/A	Shared Landing?	N/A	N/A	DWS Offset RT (in)	N/A
N/A	Gutter Ponding?	0.0	N/A	Gutter Slope (%)	N/A
N/A	Gutter Lip Ht (in)	1.0	N/A	Gutter X Slope (%)	N/A
N/A	Painted X Walk1?	No		Road Slope (%)	1.8
	X Walk 1 Direction	To S		Road X Slope (%)	7.1
	X Walk 1 Width (in)	N/A		Clear Space?	N/A

X Walk 1 Slope (%)	1.8	N/A	Clear Space to XWalk (in)	N/A
	X Walk 1 X Slope (%)	7.1	N/A	Storm Grate/Utility Hazard?	N/A
N/A	Ramp inside XWalk1?	N/A		Storm Grate/Utility Type	
N/A	Any Obstructions?	N/A			N/A
	Obstruction Type		Yes	Surface Condition? (G/P)	Good
			N/A	Curb Slope (%)	4.7

**Remove & Replace Entire Ramp.**

**R304.2.2, R304.5.3**
