# Access Compliance Report

## Public Rights-of-Way

### (Curb Ramps)

Intersection ID: 50666	Main Street: SPRINGPOINT_LN	Cross Street: SAMUEL_NEEL_RD	Location: NW
ADA ID: 1BB5C2E7EFEC	Ramp Type: Perp	Initial Pass/Fail: Fail	Overall Compliance: No
Severity Score: 25			
Codes/Mitigation Info/Possible Solution		Field Measurements/Component Compliance

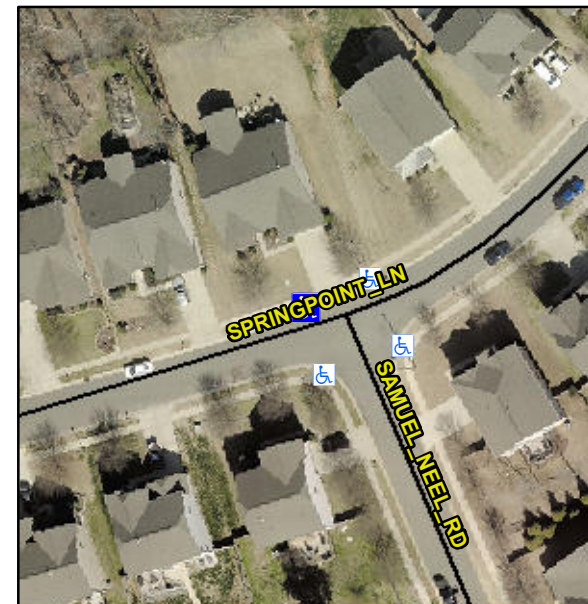
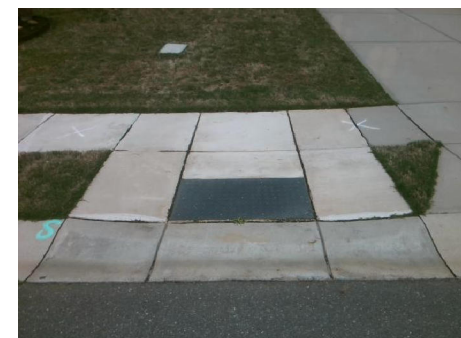
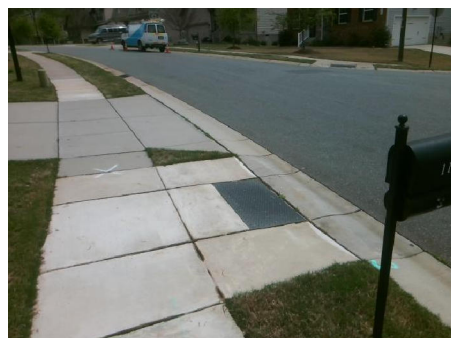
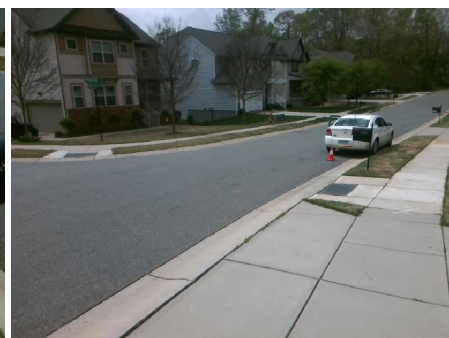
Compliance	Description	Data	Compliance	Description	Data
N/A	Ramp Length (in)	48.0	Yes	Ramp Slope (%)	5.7
Yes	Ramp Width (in)	48.0	No	Ramp XSlope (%)	7.5
N/A	Flare Type LT	N/A	N/A	Flare Type RT	N/A
N/A	Flare Slope LT (%)	N/A	N/A	Flare Slope RT (%)	N/A
N/A	Flare Traversable LT?	N/A	N/A	Flare Traversable RT?	N/A
N/A	Landing Length (in)	N/A	N/A	DWS Provided?	N/A
N/A	Landing Width (in)	N/A	N/A	DWS Contrast?	N/A
N/A	Landing Slope (%)	N/A	N/A	DWS Length (in)	N/A
N/A	Landing X Slope (%)	N/A	N/A	DWS Full Width?	N/A
N/A	Landing Curb? (Y/N)	N/A	N/A	DWS Offset (in)	N/A
N/A	Shared Landing?	N/A			
N/A	Gutter Ponding?	N/A	N/A	Gutter Slope (%)	N/A
N/A	Gutter Lip Ht (in)	N/A	N/A	Gutter X Slope (%)	N/A
N/A	Painted X Walk1?	No	N/A	Painted X Walk2?	N/A
	X Walk 1 Direction	To SE		X Walk 2 Direction	N/A
N/A	X Walk 1 Width (in)	N/A	N/A	X Walk 2 Width (in)	N/A
	X Walk 1 Slope (%)	1.9		X Walk 2 Slope (%)	N/A
	X Walk 1 X Slope (%)	5.4		X Walk 2 X Slope (%)	N/A

N/A	Ramp inside XWalk1?	N/A	N/A	Ramp inside XWalk2?	N/A
	Road Slope (%)	N/A	N/A	Clear Space?	N/A
	Road X Slope (%)	N/A	N/A	Clear Space to XWalk (in)	N/A
N/A	Any Obstructions?	N/A	N/A	Storm Grate/Utility Hazard?	N/A
	Obstruction Type			Storm Grate/Utility Type	
		N/A			N/A
			Yes	Surface Condition? (G/P)	Good

**Remove & Replace Entire Ramp.**

**R304.5.3**

Total Cost: \$ 1850.00
