Access Compliance Report

Public Rights-of-Way

(Curb Ramps)

Intersection ID: 3847	Main Street: HIGHSTREAM_CT	Cross Street: POPLAR_GROVE_DR	Location: NW
ADA ID: 1BB9A51D1314	Ramp Type: Perp	Initial Pass/Fail: Fail	Overall Compliance: No
			Severity Score: 21.25

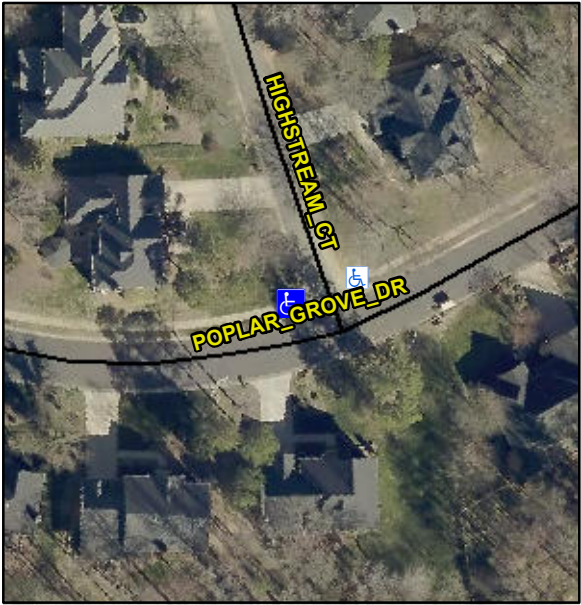
Possible Solutions:		Compliance	Description	Data
	Remove & Replace Entire Ramp.		No	Ramp Length (in)	41.0
			No	Ramp Width (in)	47.0
			N/A	Flare Type LT	N/A
			N/A	Flare Slope LT (%)	N/A
			N/A	Flare Traversable LT?	N/A
			N/A	Landing Length (in)	N/A
			N/A	Landing Width (in)	N/A
			N/A	Landing Slope (%)	N/A
			N/A	Landing X Slope (%)	N/A
<p>Surveyor Notes:</p> <p>N/A</p> <p>PROW/ADA:</p> <p>Not Found, R304.5.1, R304.2.2</p>			N/A	Flare Type RT	N/A
			N/A	Flare Slope RT (%)	N/A
			N/A	Flare Traversable RT?	N/A
			N/A	DWS Provided?	N/A
			N/A	DWS Contrast?	N/A
			N/A	DWS Length (in)	N/A
			N/A	DWS Full Width?	N/A
			N/A	DWS Offset (in)	N/A
			N/A	Gutter Ponding?	N/A
			N/A	Gutter Lip Ht (in)	N/A
			No	Painted X Walk1?	N/A
				X Walk 1 Direction	To E
			N/A	X Walk 1 Width (in)	N/A
				X Walk 1 Slope (%)	2.2
				X Walk 1 X Slope (%)	1.2
