# Access Compliance Report

## Public Rights-of-Way

### (Curb Ramps)

Intersection ID: 47853	Main Street: EL_CAMPO_CT	Cross Street: STONE_PORCH_RD	Location: SE
ADA ID: 1BBAF4BD7740	Ramp Type: PerpDiag	Initial Pass/Fail: Fail	Overall Compliance: No
Severity Score: 22.5			
Codes/Mitigation Info/Possible Solution		Field Measurements/Component Compliance

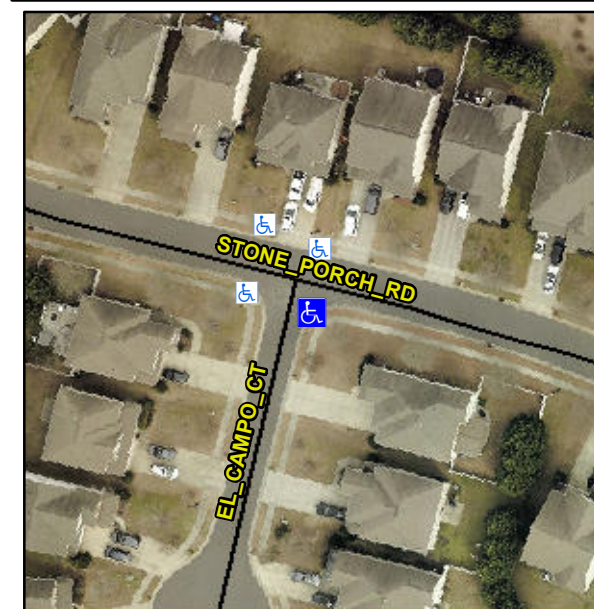
**Not Found, R304.5.1, R304.2.2, R304.5.3**

Compliance	Description	Data	Compliance	Description	Data
N/A	Ramp Length (in)	48.0	No	Ramp Slope (%)	11.7
No	Ramp Width (in)	44.0	No	Ramp XSlope (%)	2.6
N/A	Flare Type LT	N/A	N/A	Flare Type RT	N/A
N/A	Flare Slope LT (%)	N/A	N/A	Flare Slope RT (%)	N/A
N/A	Flare Traversable LT?	N/A	N/A	Flare Traversable RT?	N/A
N/A	Landing Length (in)	N/A	N/A	DWS Provided?	N/A
N/A	Landing Width (in)	N/A	N/A	DWS Contrast?	N/A
N/A	Landing Slope (%)	N/A	N/A	DWS Length (in)	N/A
N/A	Landing X Slope (%)	N/A	N/A	DWS Full Width?	N/A
N/A	Landing Curb? (Y/N)	N/A	N/A	DWS Offset (in)	N/A
N/A	Shared Landing?	N/A			
N/A	Gutter Ponding?	N/A	N/A	Gutter Slope (%)	N/A
N/A	Gutter Lip Ht (in)	N/A	N/A	Gutter X Slope (%)	N/A
N/A	Painted X Walk1?	No	N/A	Painted X Walk2?	No
	X Walk 1 Direction	To NE		X Walk 2 Direction	To NW
N/A	X Walk 1 Width (in)	N/A	N/A	X Walk 2 Width (in)	N/A
	X Walk 1 Slope (%)	1.5		X Walk 2 Slope (%)	2.4
	X Walk 1 X Slope (%)	0.6		X Walk 2 X Slope (%)	0.8

N/A	Ramp inside XWalk1?	N/A	N/A	Ramp inside XWalk2?	N/A
	Road Slope (%)	0.8	N/A	Clear Space?	N/A
	Road X Slope (%)	0.6	N/A	Clear Space to XWalk (in)	N/A
N/A	Any Obstructions?	N/A	N/A	Storm Grate/Utility Hazard?	N/A
	Obstruction Type			Storm Grate/Utility Type	
		N/A			N/A
			Yes	Surface Condition? (G/P)	Good

**Remove & Replace Curb Ramp With Two New Directional Ramps or Equivalent.**
