Access Compliance Report Public Rights-of-Way (Curb Ramps)

Intersection ID: N/A Main Street: CANTERBURY_CASTLE_DR Cross Street: SAGMORE_HILL_DR Location: N

ADA ID: 1BBC14707612 **Overall Compliance: No** Ramp Type: Perp Initial Pass/Fail: Fail **Severity Score:** 8.75

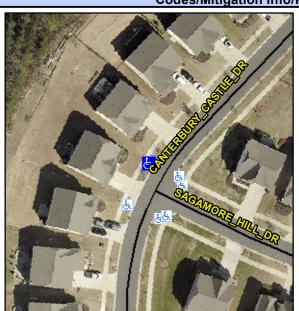
Field Measurements/Component Compnance							
Comp	liance Description	Data	Comp	liance Description	Data		
N/A	Ramp Length (in)	96.0	Yes	Ramp Slope (%)	6.0		
No	Ramp Width (in)	47.0	Yes	Ramp XSlope (%)	1.6		
N/A	Flare Type LT	N/A	N/A	Flare Type RT	N/A		
N/A	Flare Slope LT (%)	N/A	N/A	Flare Slope RT (%)	N/A		
N/A	Flare Traversable LT?	N/A	N/A	Flare Traversable RT?	N/A		
N/A	Landing Length (in)	N/A	N/A	DWS Provided?	N/A		
N/A	Landing Width (in)	N/A	N/A	DWS Contrast?	N/A		
N/A	Landing Slope (%)	N/A	N/A	DWS Length (in)	N/A		
N/A	Landing X Slope (%)	N/A	N/A	DWS Full Width?	N/A		
N/A	Landing Curb? (Y/N)	N/A	N/A	DWS Offset (in)	N/A		
N/A	Shared Landing?	N/A					
N/A	Gutter Ponding?	N/A	N/A	Gutter Slope (%)	N/A		
N/A	Gutter Lip Ht (in)	N/A	N/A	Gutter X Slope (%)	N/A		
N/A	Painted X Walk1?	No	N/A	Painted X Walk2?	N/A		
	X Walk 1 Direction	To SE		X Walk 2 Direction	N/A		
N/A	X Walk 1 Width (in)	N/A	N/A	X Walk 2 Width (in)	N/A

X Walk 1 Slope (%)	2.0		X Walk 2 Slope (%)	N/A		
	X Walk 1 X Slope (%)	0.9		X Walk 2 X Slope (%)	N/A		
N/A	Ramp inside XWalk1?	N/A	N/A	Ramp inside XWalk2?	N/A		
	Road Slope (%)	N/A	N/A	Clear Space?	N/A		
	Road X Slope (%)	N/A	N/A	Clear Space to XWalk (in)	N/A		
N/A	Any Obstructions?	N/A	N/A	Storm Grate/Utility Hazard?	N/A		
	Obstruction Type		l	Storm Grate/Utility Type			
		N/A			N/A		
			Yes	Surface Condition? (G/P)	Good

OSSIDIE OCIULION							
Possible Solutions:							
Remove & Replace Entire Ramp.							
Surveyor Notes:							
N/A							
PROW/ADA:							
R304.5.1
