## **Access Compliance Report Public Rights-of-Way** (Curb Ramps)

Intersection ID: 10034533 Main Street: PINEVILLE-MATTHEWS\_RD Cross Street: N/A Location: N

ADA ID: 1BBD5713D006 Ramp Type: Perp Initial Pass/Fail: Fail **Overall Compliance: No Severity Score:** 12.5

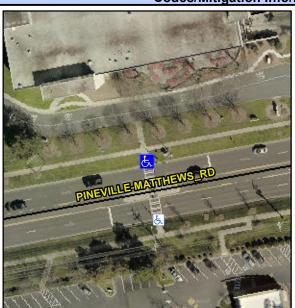
Field Measurements/Component Compliance								
Compliance Description Date			Comp	liance Description	Data			
N/A	Ramp Length (in)	156.0	No	Ramp Slope (%)	9.5			
Yes	Ramp Width (in)	71.0	Yes	Ramp XSlope (%)	0.9			
N/A	Flare Type LT	N/A	N/A	Flare Type RT	N/A			
N/A	Flare Slope LT (%)	N/A	N/A	Flare Slope RT (%)	N/A			
N/A	Flare Traversable LT?	N/A	N/A	Flare Traversable RT?	N/A			
N/A	Landing Length (in)	N/A	N/A	DWS Provided?	N/A			
N/A	Landing Width (in)	N/A	N/A	DWS Contrast?	N/A			
N/A	Landing Slope (%)	N/A	N/A	DWS Length (in)	N/A			
N/A	Landing X Slope (%)	N/A	N/A	DWS Full Width?	N/A			
N/A	Landing Curb? (Y/N)	N/A	N/A	DWS Offset (in)	N/A			
N/A	Shared Landing?	N/A						
N/A	Gutter Ponding?	N/A	N/A	Gutter Slope (%)	N/A			
N/A	Gutter Lip Ht (in)	N/A	N/A	Gutter X Slope (%)	N/A			
N/A	Painted X Walk1?	Yes	N/A	Painted X Walk2?	N/A			
	X Walk 1 Direction	To S		X Walk 2 Direction	N/A			
N/A	X Walk 1 Width (in)	106.0	N/A	X Walk 2 Width (in)	N/A

X Walk 1 Slope (%)	2.1		X Walk 2 Slope (%)	N/A			
	X Walk 1 X Slope (%)	1.5		X Walk 2 X Slope (%)	N/A			
N/A	Ramp inside XWalk1?	Yes	N/A	Ramp inside XWalk2?	N/A			
	Road Slope (%)	N/A	N/A	Clear Space?	N/A			
	Road X Slope (%)	N/A	N/A	Clear Space to XWalk (in)	N/A			
N/A	Any Obstructions?	N/A	N/A	Storm Grate/Utility Hazard?	N/A			
	Obstruction Type			Storm Grate/Utility Type				
		N/A			N/A			
			Yes	Surface Condition? (G/P)	Good

Possible Solutions:	Co
Remove & Replace Entire Ramp.	N/A
	Yes
	N/A
	N/A
	N/A
	N/A
Surveyor Notes:	N/A
N/A	N/A
	N/A
	N/A
	N/A
PROW/ADA:	N/A
Not Found, R304.2.2	N/A
·	N/A
	N/A
	N/A

Surveyor Notes:		N/A
N/A		N/A
		N/A
		N/A
		N/A
PROW/ADA:		N/A
Not Found, R304.2.2		N/A
		N/A
		N/A
		N/A
Total Cost:	\$ 1850.00	N/A
