# Access Compliance Report

## Public Rights-of-Way

### (Curb Ramps)

| Intersection ID: 17247 | Main Street: RANDOLPH_RD | Cross Street: S_CANTERBURY_RD | Location: W |

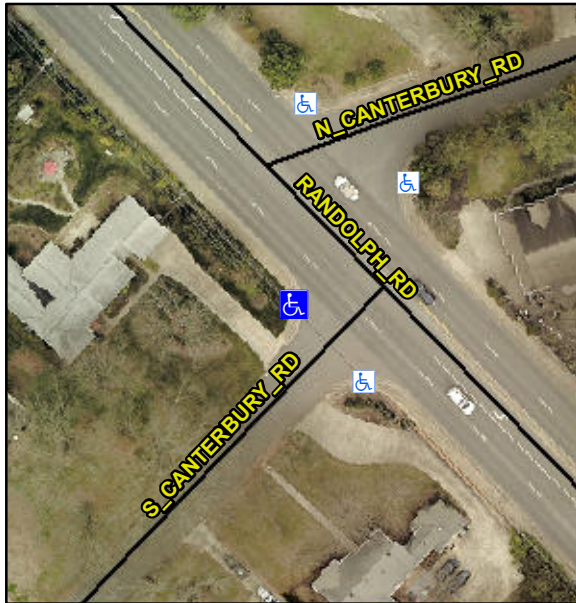
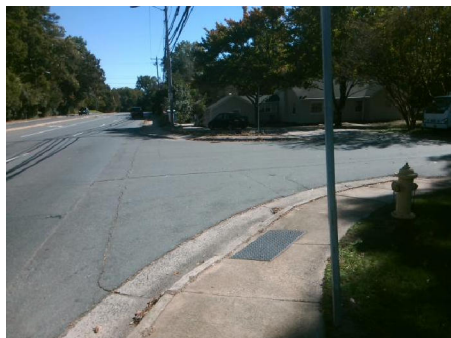
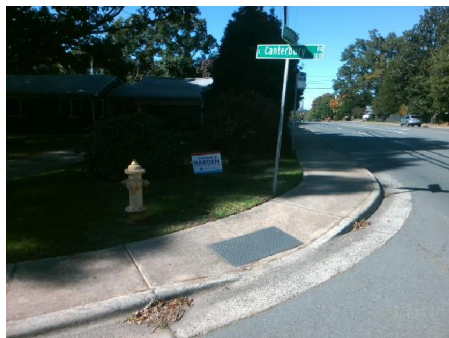
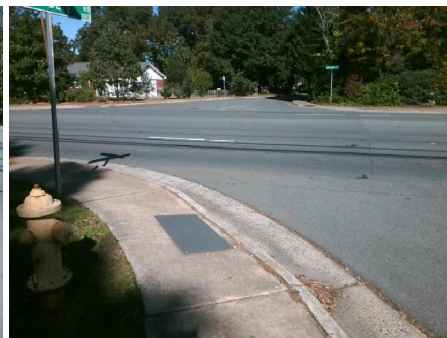
| ADA ID: 1BBFDC538DA6 | Ramp Type: PerpDiag | Initial Pass/Fail: Fail | Overall Compliance: No |

| Compliance | Description | Data | Compliance | Description | Data |
|---|---|---|---|---|---|
| N/A | Ramp Length (in) | 53.0 | No | Ramp Slope (%) | 13.6 |
| Yes | Ramp Width (in) | 48.0 | No | Ramp XSlope (%) | 3.4 |

**Remove & Replace Curb Ramp With Two New Directional Ramps or Equivalent.**

**R304.2.2, R304.5.3**

Total Cost: \$ **3200.00**
