# Access Compliance Report

## Public Rights-of-Way

### (Curb Ramps)

| Intersection ID: 44481 | Main Street: CHALKSTONE_RD | Cross Street: REDDING_GLEN_AV | Location: NW |

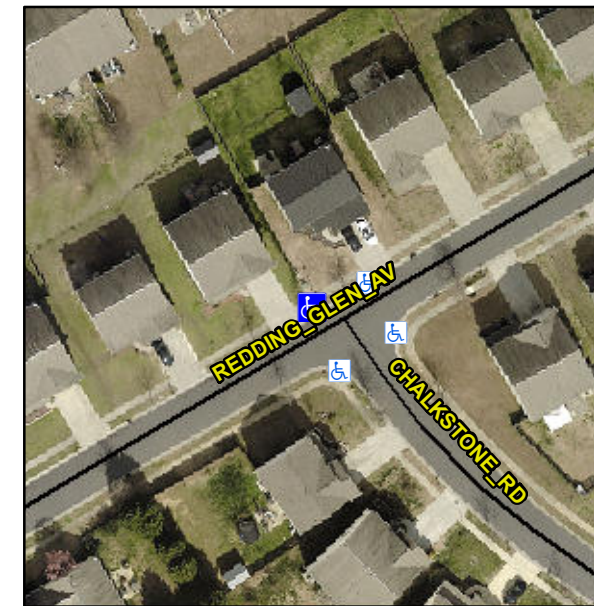
| ADA ID: 1BC01F202A7A | Ramp Type: Perp | Initial Pass/Fail: Fail | Overall Compliance: No |
| Severity Score: 10 | | | |

**Not Found, R304.5.1, R304.5.3**

| Compliance | Description | Data | Compliance | Description | Data |
|---|---|---|---|---|---|
| N/A | Ramp Length (in) | 48.0 | Yes | Ramp Slope (%) | 6.5 |
| No | Ramp Width (in) | 47.5 | No | Ramp XSlope (%) | 3.3 |

**Remove & Replace Entire Ramp.**

Total Cost: \$ 1850.00
