Access Compliance Report

Public Rights-of-Way

(Curb Ramps)

| Intersection ID: 15564 | Main Street: CHEROKEE_RD | Cross Street: COTTAGE_PL | Location: NW |

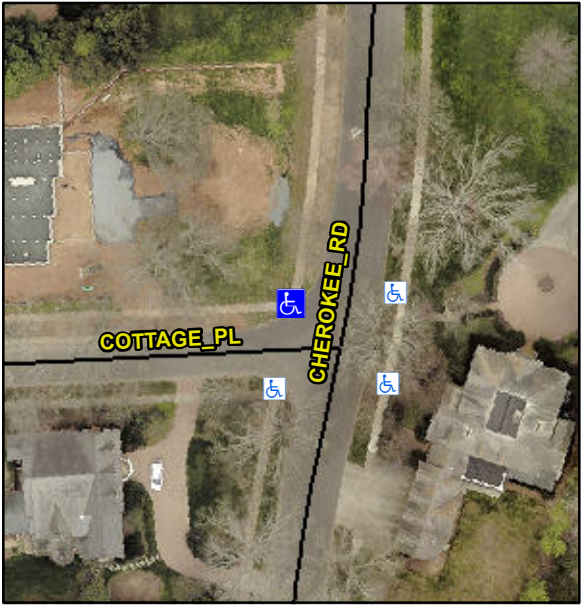
| ADA ID: 1BC2E7149F35 | Ramp Type: PerpDiag | Initial Pass/Fail: Fail | Overall Compliance: No |

| Codes/Mitigation Info/Possible Solution | | | Field Measurements/Component Compliance | | |
|--|---|--|---|---|---|
| | Remove & Replace Curb Ramp With Two New Directional Ramps or Equivalent. | | No | Ramp Length (in) | 46.0 |
| <p>Surveyor Notes:</p> <p>N/A</p> <p>PROW/ADA:</p> <p>R304.2.2, R304.5.3</p> | | | N/A | Flare Type RT | N/A |

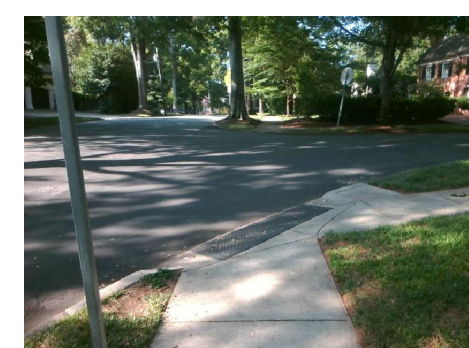
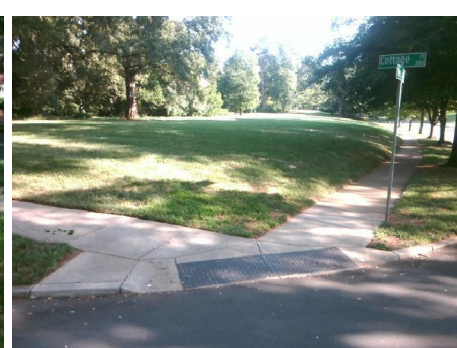
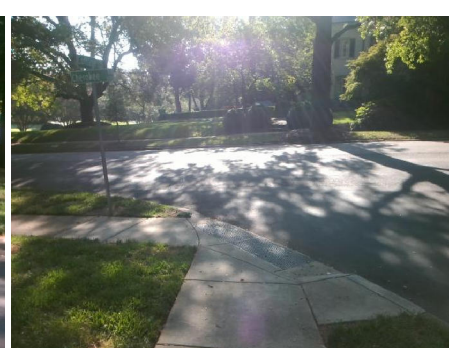
| Codes/Mitigation Info/Possible Solution | | | Field Measurements/Component Compliance | | |
|--|---|--|---|---|---|
| | | | Yes | Surface Condition? (G/P) | Good |
